ENVIRONMENTAL MONITORING REPORT

Project Number: 49042-004

Reporting period: July-December 2020

Republic of Tajikistan: CENTRAL ASIA REGIONAL ECONOMIC COOPERATION (CAREC) CORRIDORS 2, 5, and 6 (DUSHANBE- KURGONTEPPA) ROAD PROJECT

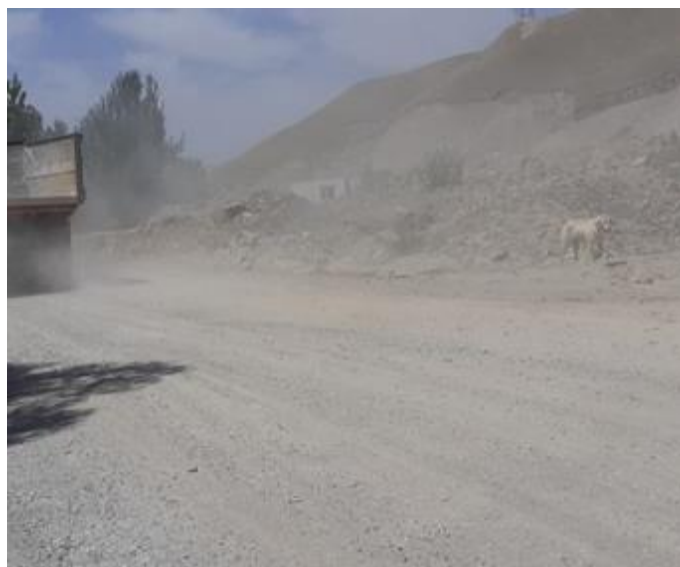
68. The biggest borrow area of the project is located towards the beginning of the road section, roughly 5+000 kilometres to the west side of the road from the junction towards Chimteppa. The borrow area is located right next to a residential area, and the hauling route travels next to houses for almost full length of the way from the project road. As mentioned earlier, inadequate dust suppression was being done on the hauling route to this borrow area during sunny days. During reporting period the Contractor increased the number of trips for watering of the project road and decreased the level of the dust suppression.

Photo 2 – The Road watering was increased to decrease the dust suppression - July, 2020.

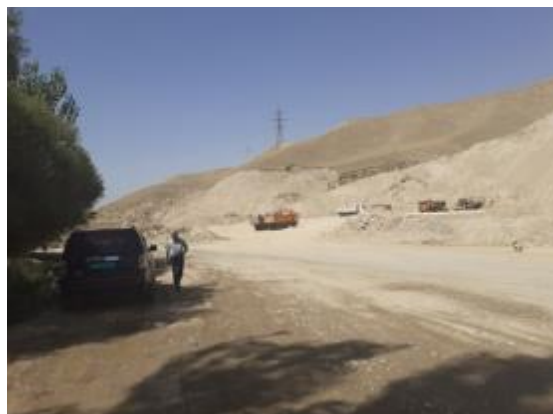
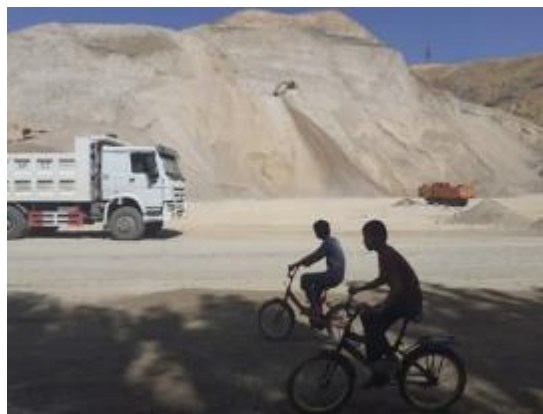
Photo 3 – Some dust suppression has also been done, but fencing is absent and dustiness often persists – August, 2020

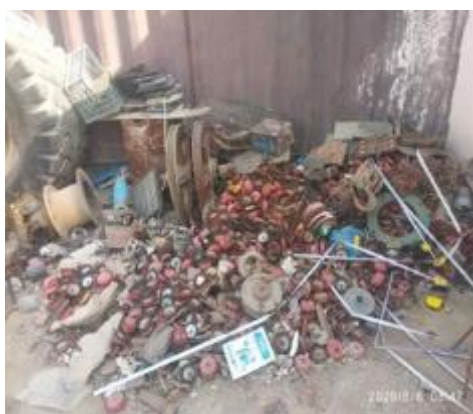
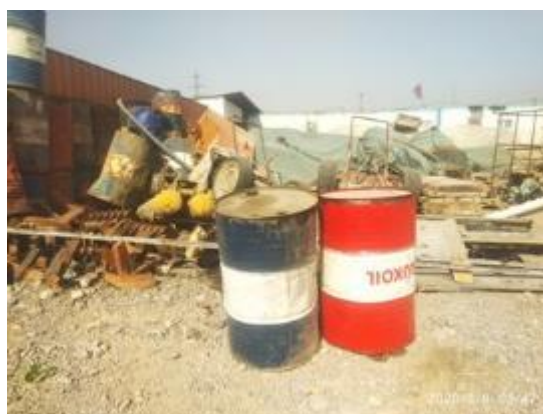
73. One of the main issues at the contractor's main camp at km9+700 is poor waste management. Although the camp is seemingly in an organized and tidy condition, there have been several observations where the environmental management of the camp is not being done in accordance with the SEMP.
74. About 193 workers live currently in the camp (Tajiks and Chinese). All necessary sanitary facilities have been provided (water, toilets, showers). There is an agreement for taking care of patients at the camp with the local hospital of Rudaky district. The kitchens and

77. During the CSC environmental specialist visits, oil/lubricant spills were observed at the maintenance area of the camp and maintenance of vehicles was being done on open ground. The storage of fuel is in compliance and meets the requirements (fenced, placed on impervious basis and has containment area).

78. No containers for the oily clothes, gloves, etc. had been provided and there is no waste separation.
79. The construction camp at km 24 is used by about 14 workers. No observations of poor environmental management at this camp were made by the ES of the CSC.

Photo 4 - Improper waste storage at the contractors main camp, km 9+700 - October, 2020.

94. The ES has restated the requirements to sign contracts, maintain records of the amounts of hazardous waste generated, and keep receipts of the collection of waste once again.

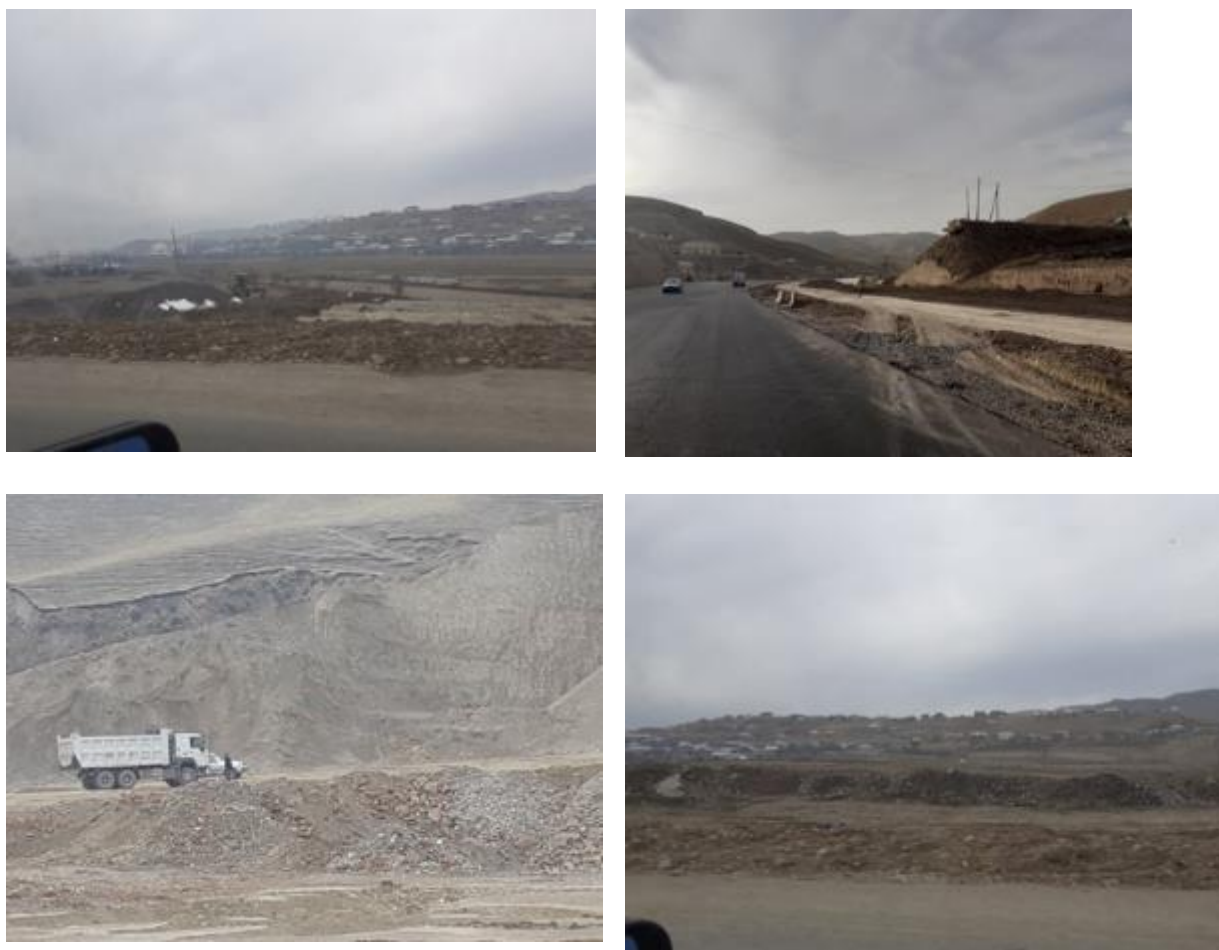
Photo 1. Spoil dumping and dust on the road in November, 2020.

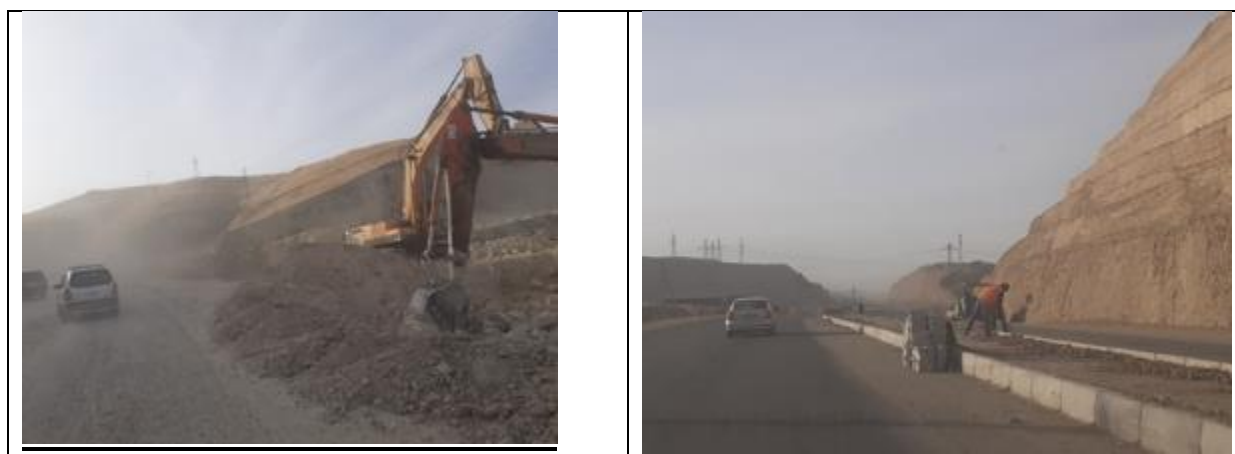
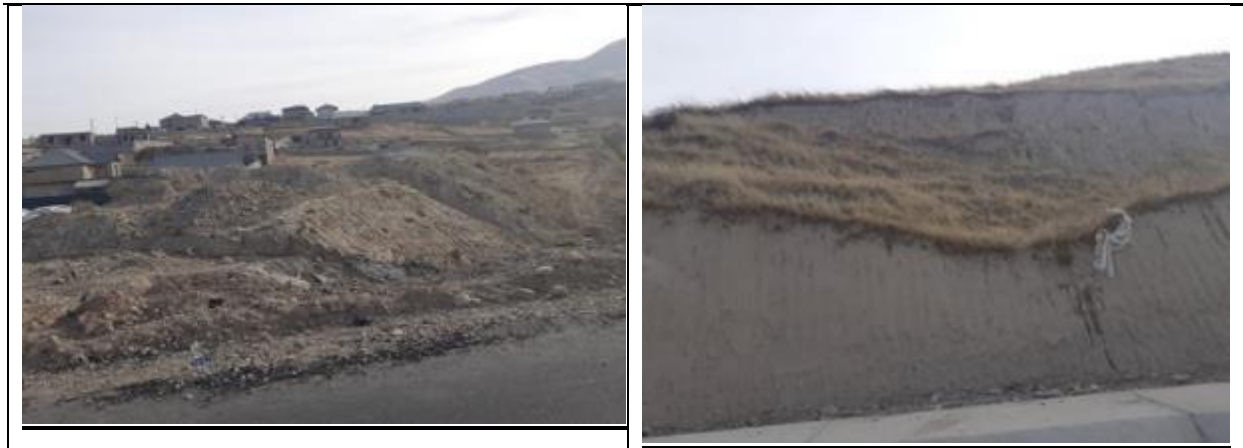
Photo 2. Earthworks and slopes in October, 2020.

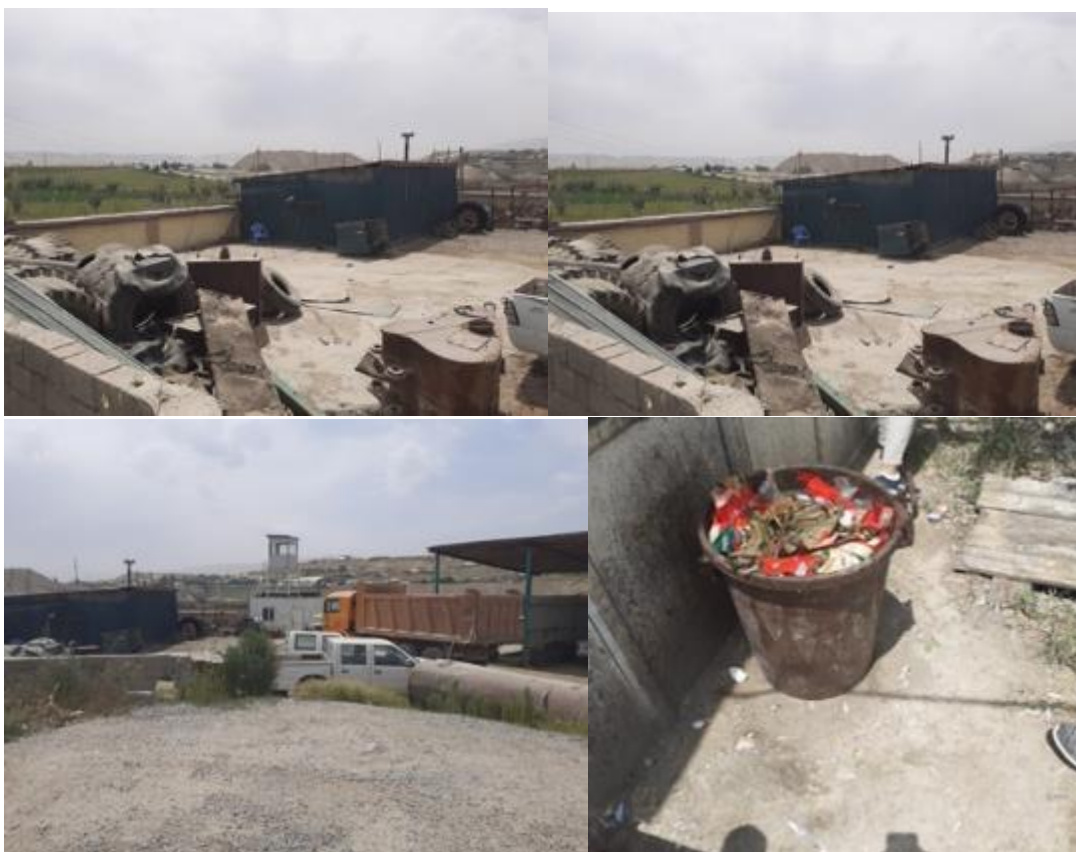
Photo 3. Environmental monitoring at the main camp at km 9+000 in July, 2020 – waste management.

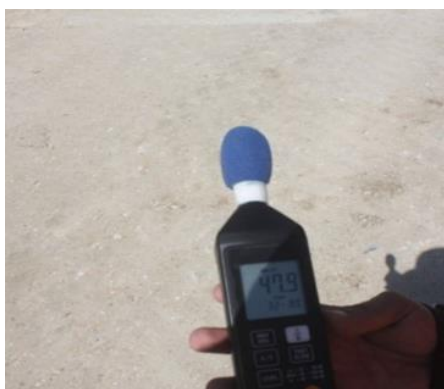
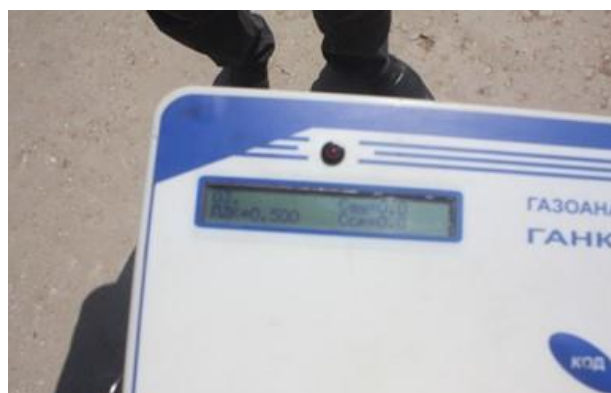
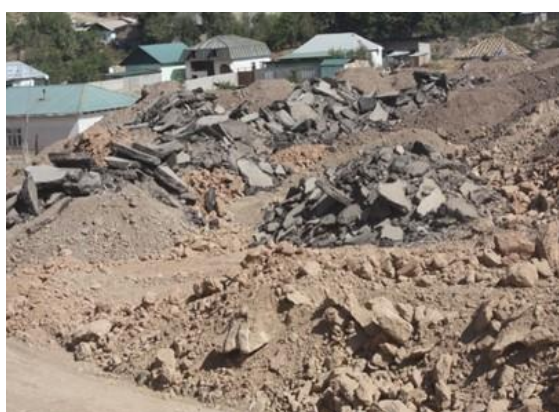
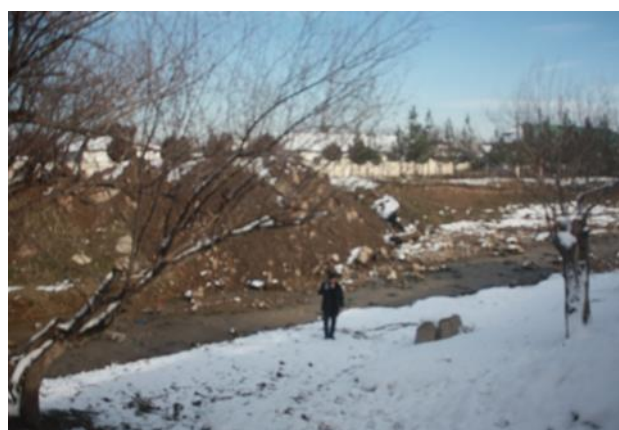
Photo 4. Environmental monitoring in December, 2020 near the contractor's main camp at km 9+000 as well as the dumping site for used asphalt at km17+900 .
