SEMI-ANNUAL ENVIRONMENTAL MONITORING REPORT

Reporting period: January-June 2020

Republic of Tajikistan: CENTRAL ASIA ECONOMIC COOPERATION CORRIDORS 2, 5, and 6 (DUSHANBE – KURGONTEPPA) ROAD PROJECT - Additional Financing

Prepared by Kocks Consult GmbH; Germany for the Ministry of Transport of the Republic of Tajikistan and the Asian Development Bank

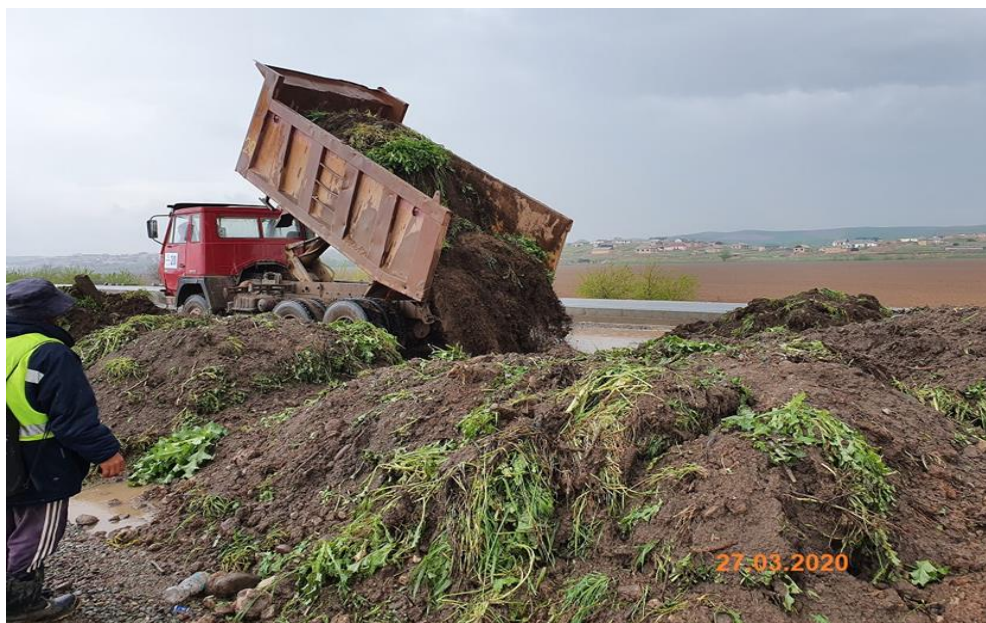
Photo 6. Dumping of the stripped top-soil at km 55+000,(taken in March 2020)

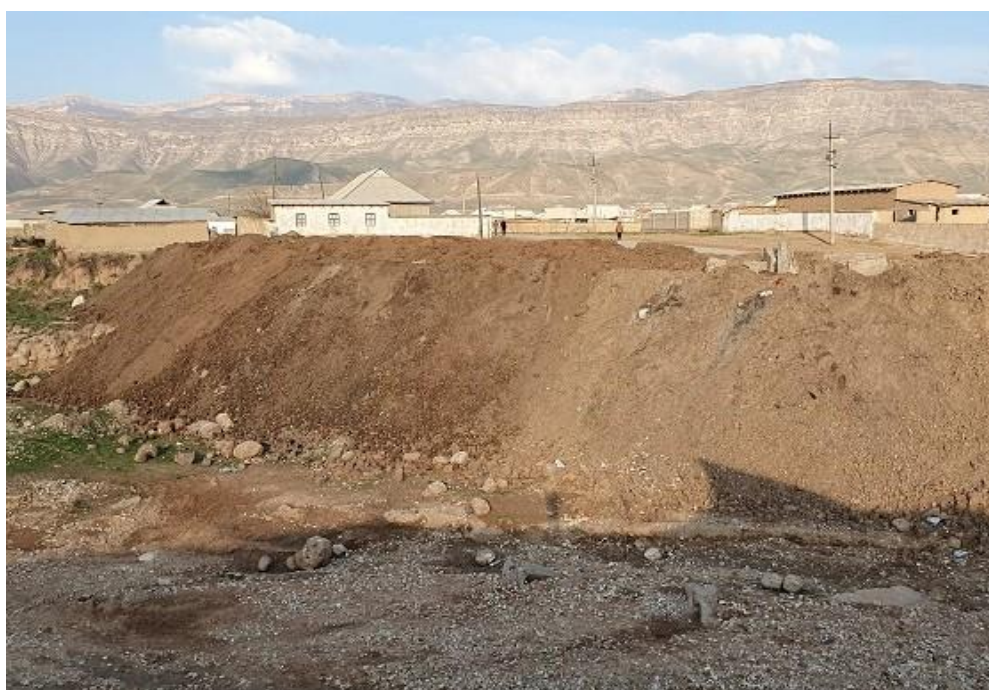
Photo 9 The dumped unsuitable material at km 42+100, (taken in March 2020)

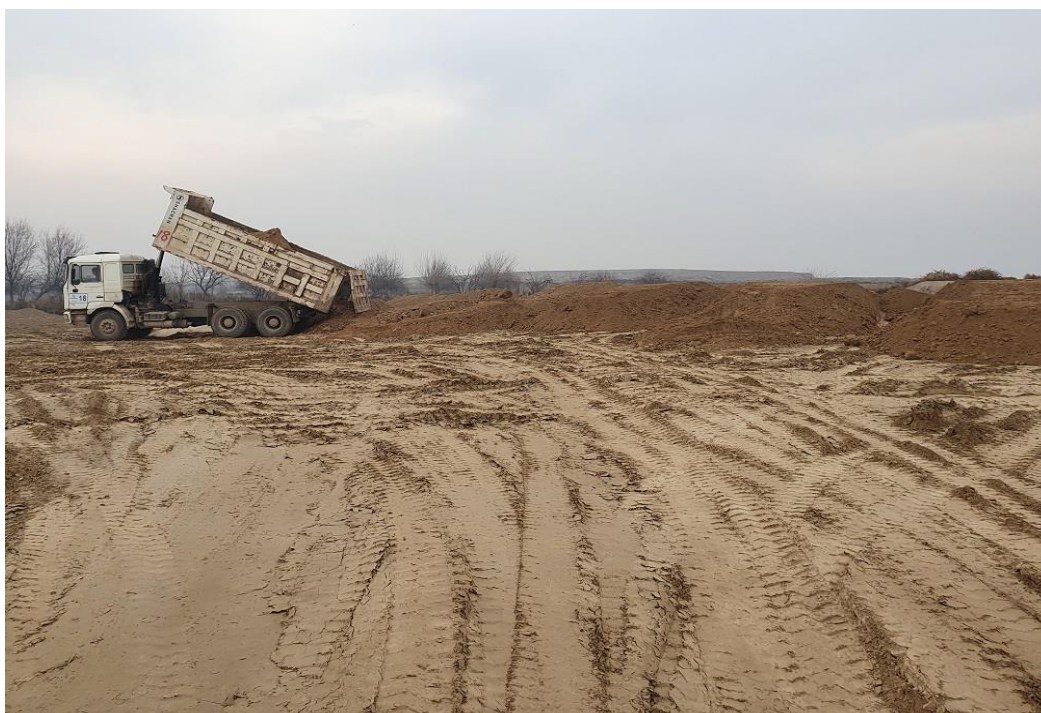
By agreement with communities and relevant authorities the Contractor also dumped and graded the unsuitable material excavated for the road widening from km 57 to 60 for the extension of the local cemetery located from the left side of the road.

Photo 10 Dumping of unsuitable soil material for extension of cemetery (Taken in January 2020),

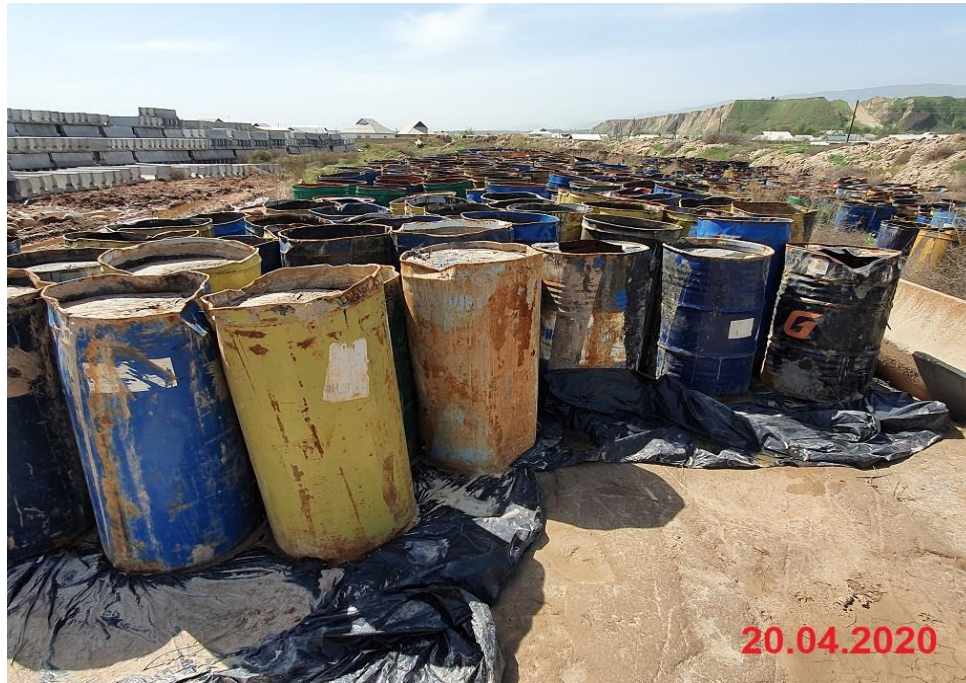
No	Issue	Significance	Status
			enforced.
18	Storage of bitumen drums without proper cover and outside of impermeable foundation.	medium	Open. The Contractor still did not conduct the proper mitigation of this issue.

Photo 13 Bitumen drums stored on the compacted clay plus plastic clay (April 2020)

95. The significant part of storage area is currently vacant and should be prepared for the safe storage of new deliveries of bitumen. Contractor was instructed to clean up the area properly and prepare impermeable platform (concrete lining or gravel foundation with plastic film on the top. However, this requirement was not fully implemented by the end of reporting period.

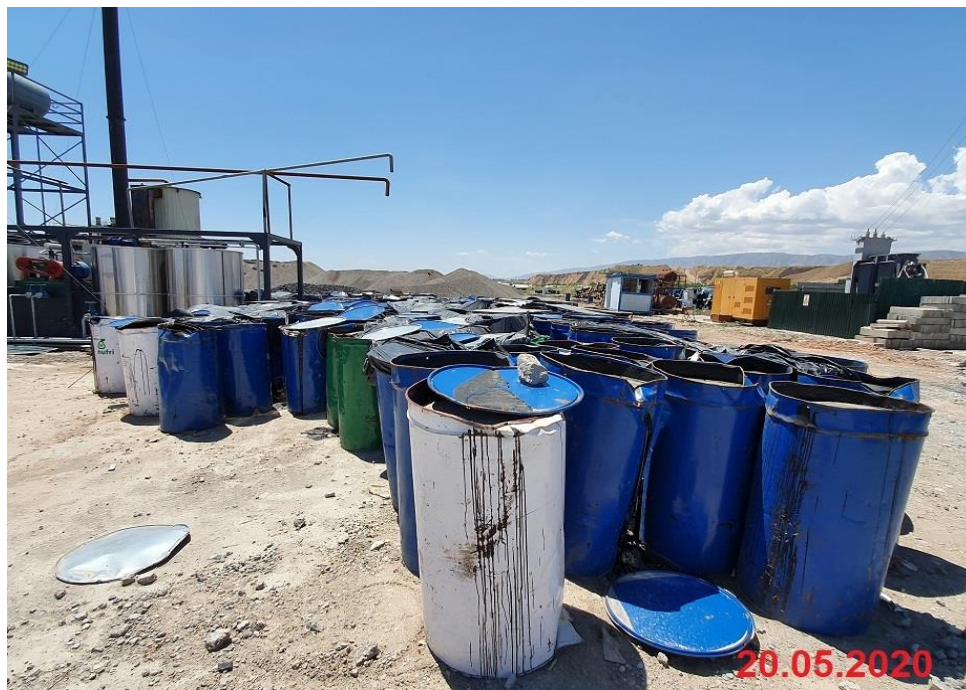
Photo 14 Drums transferred to more suitable location and covered, however compliance is not achieved yet (May 2020)

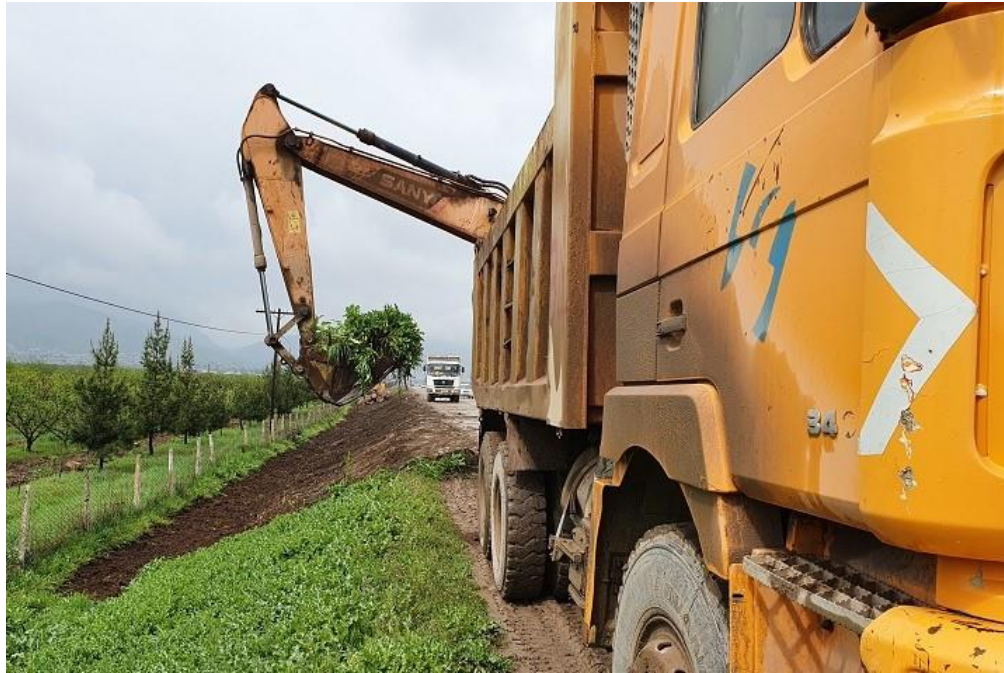
Photo 15 Removal of topsoil from km 42+500 (March 2020)

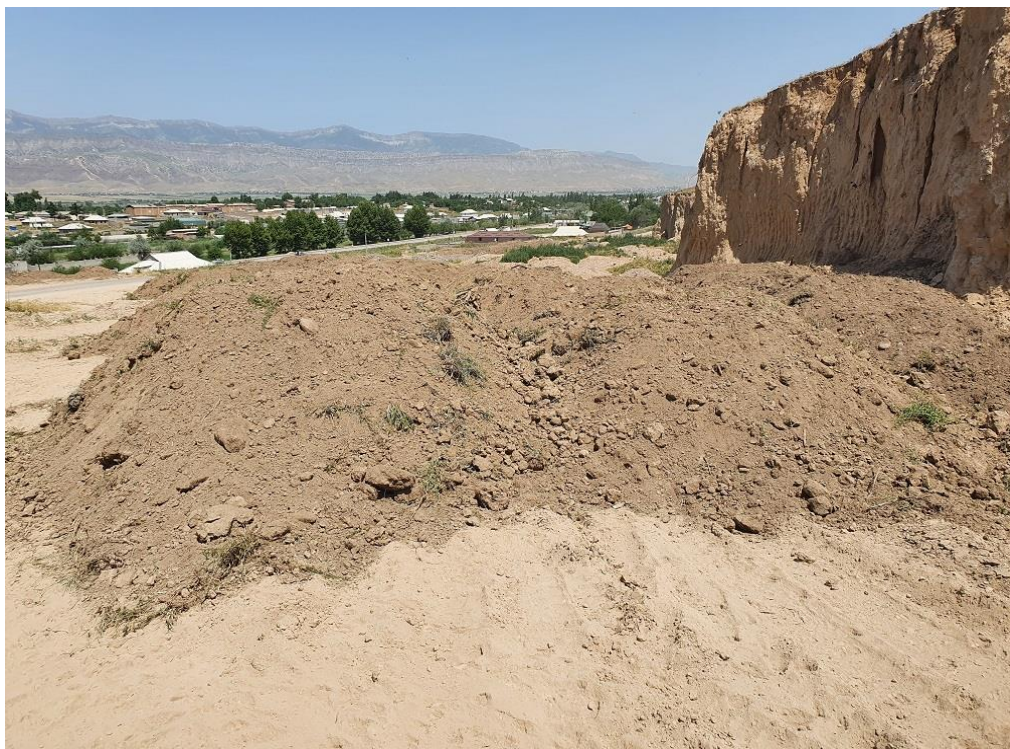
Photo 16 Storage of top-soil at km 48+500 (LHS) (May 2020)

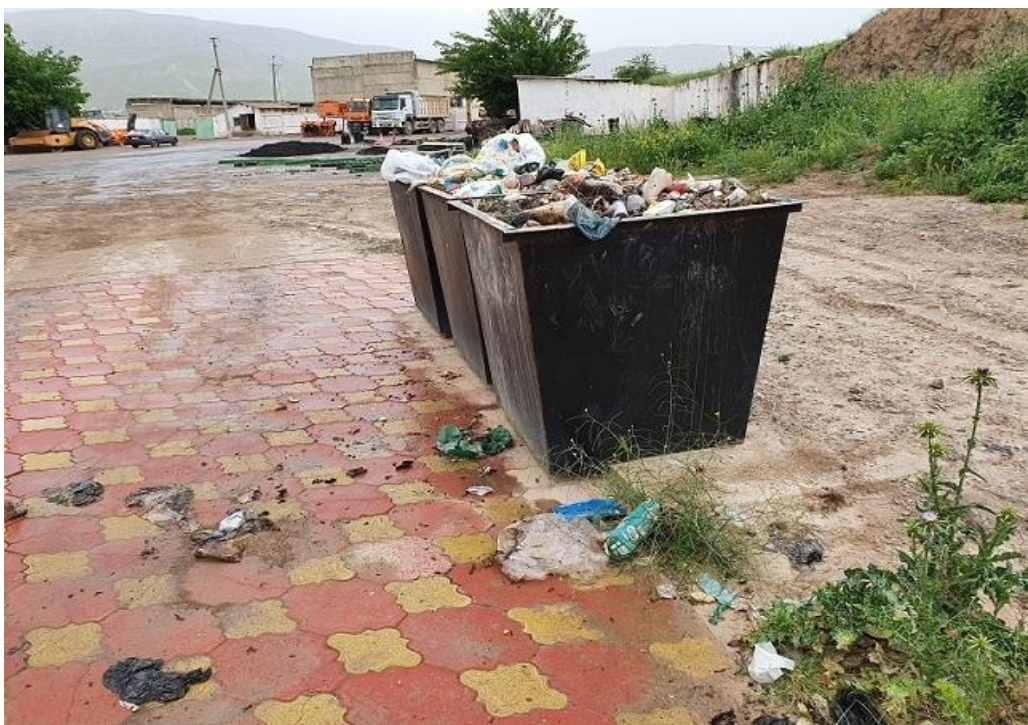
**Photo 17 Removal of garbage from the Engineer's Camp not always conducted timely
(March 2020)**

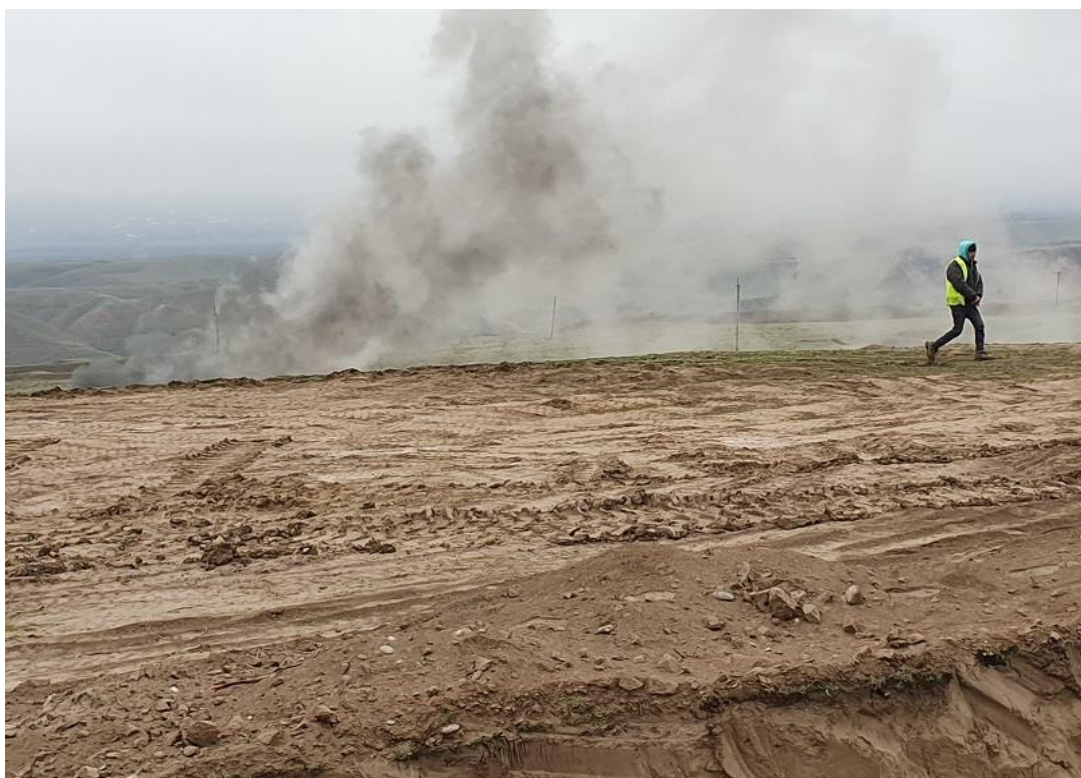
Photo 18 The smoke from the open air fire at km 58+200 (February 2020)

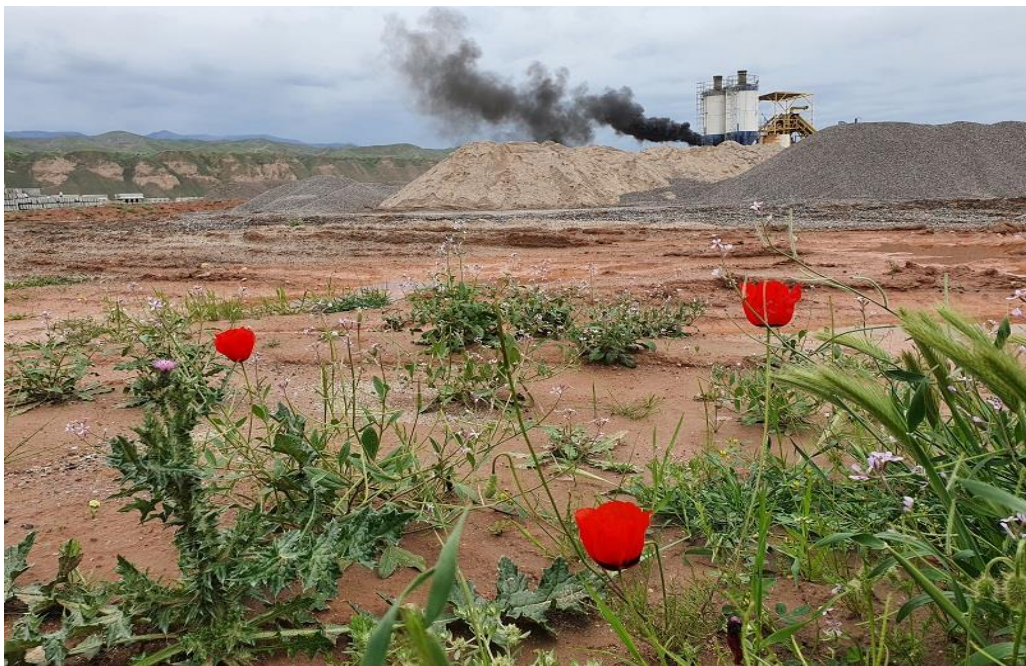
Photo 19 The black smoke from the asphalt plant chimney after restarting of work (April 2020)

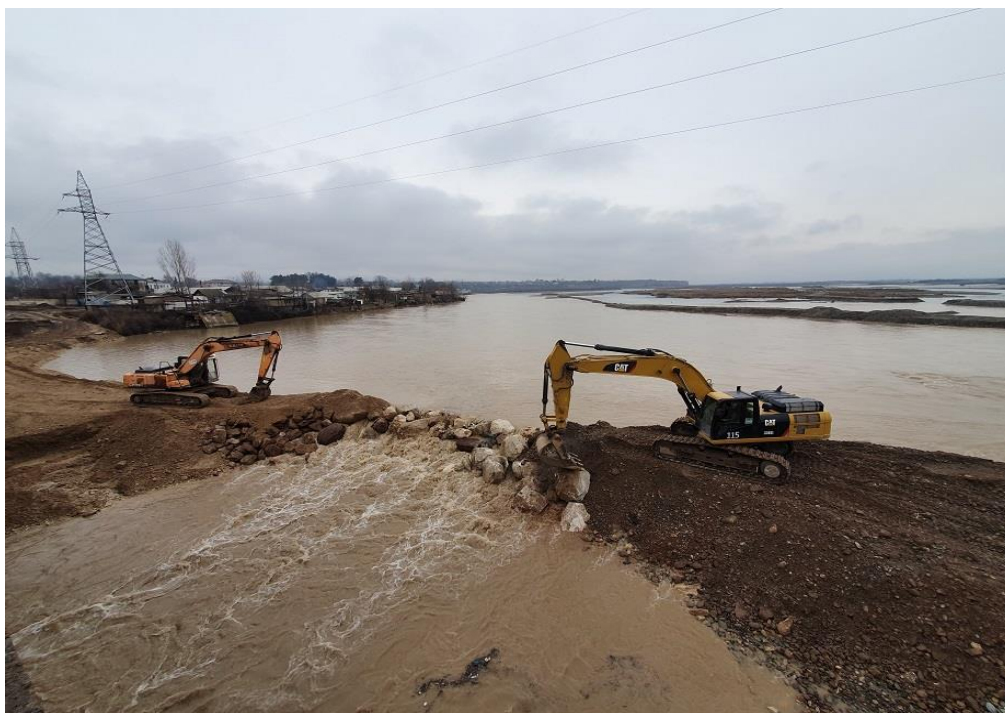
No	Issue	Significance	Status
1	Polluting of water during the construction of cofferdam	medium	Closed. The silty gravel material was replaced by material with domination of big stones. (Photo 20)
2	Siltation of the market area due to heavy raining	medium	Closed. The consequences of the siltation are eliminated, contractor helped to the local residents to clean it up.
3	The open air fire nearby the RoW for warming up during the cold weather	minor	Closed. The Contractor provided people with tent for shelter during the cold weather,
4	The formation of ponded water due to blockage of the river by dumped material upstream from the bridge#7.	minor	Closed. NCN was forwarded to the contractor. The channel was excavated to ensure the drainage
5	The various garbage dumped on the newly built embankment at km 58+200	minor	Closed. Contractor stated that garbage was dumped by the outsiders at night time. However, Contractor cleaned area and sent garbage to the approved location, after instruction of Engineer

Photo 20 Construction of cofferdam o divert water from the Right Bank of the Vakhsh River (February 2020)

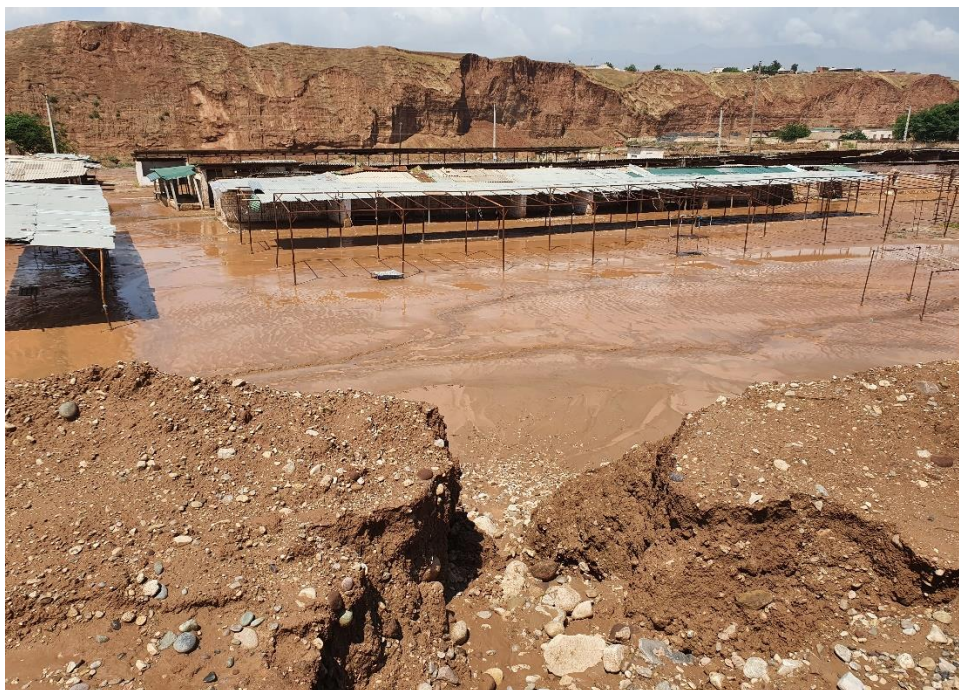
Photo 21 The silted market area at km 60+000 after heavy rains (May 2020)

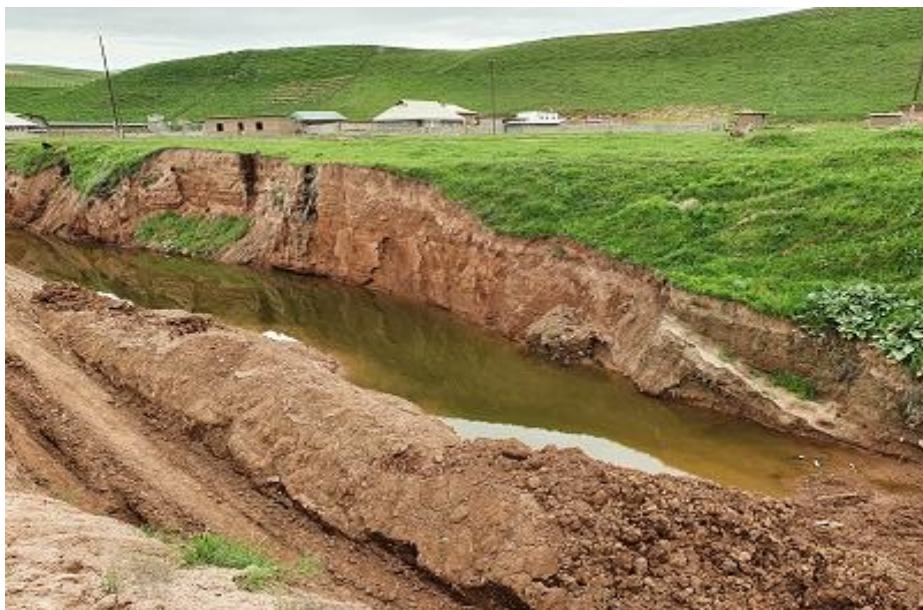
Photo 22 Water pond formed due blockage of stream at km 34+615 (April 2020)

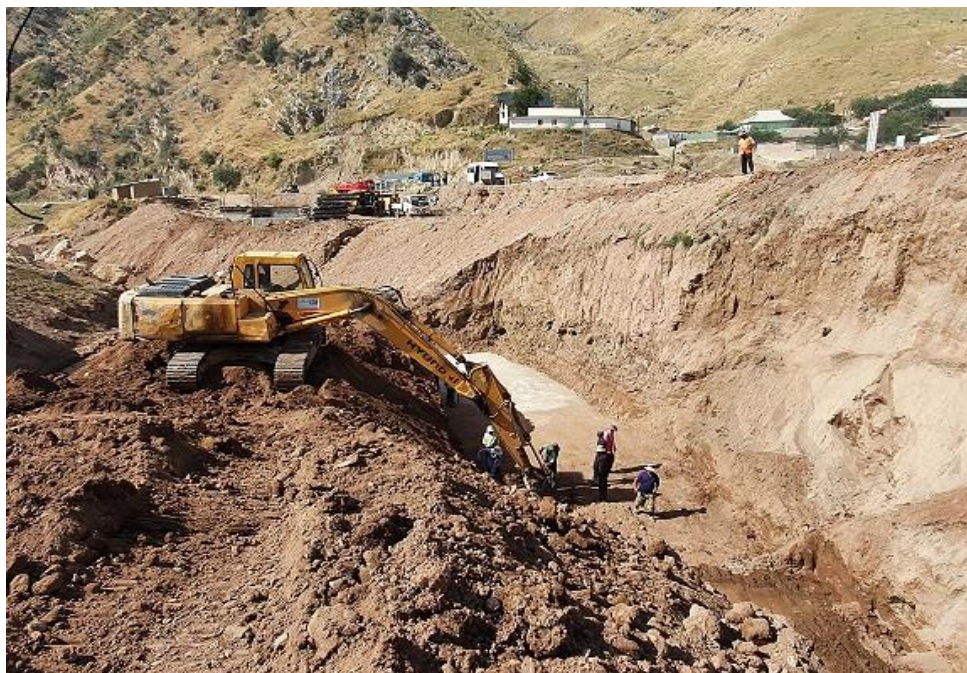
Photo 23 Cleaning of the stream channel to release water (April 2020)
