## SEMI-ANNUAL ENVIRONMENTAL MONITORING REPORT

Project Number: 49042-005

Reporting period: July-December 2019

### Republic of Tajikistan: CENTRAL ASIA ECONOMIC COOPERATION CORRIDORS 2, 5, and 6 (DUSHANBE – KURGONTEPPA) ROAD PROJECT - Additional Financing

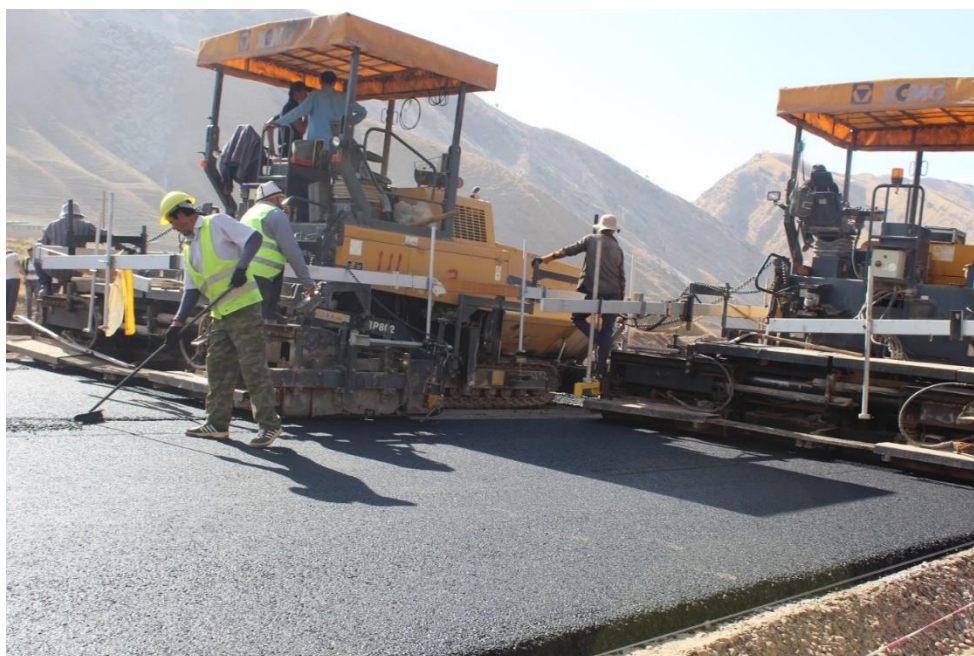
**Photo 1 The laying of binder asphalt layer at km 34+600**

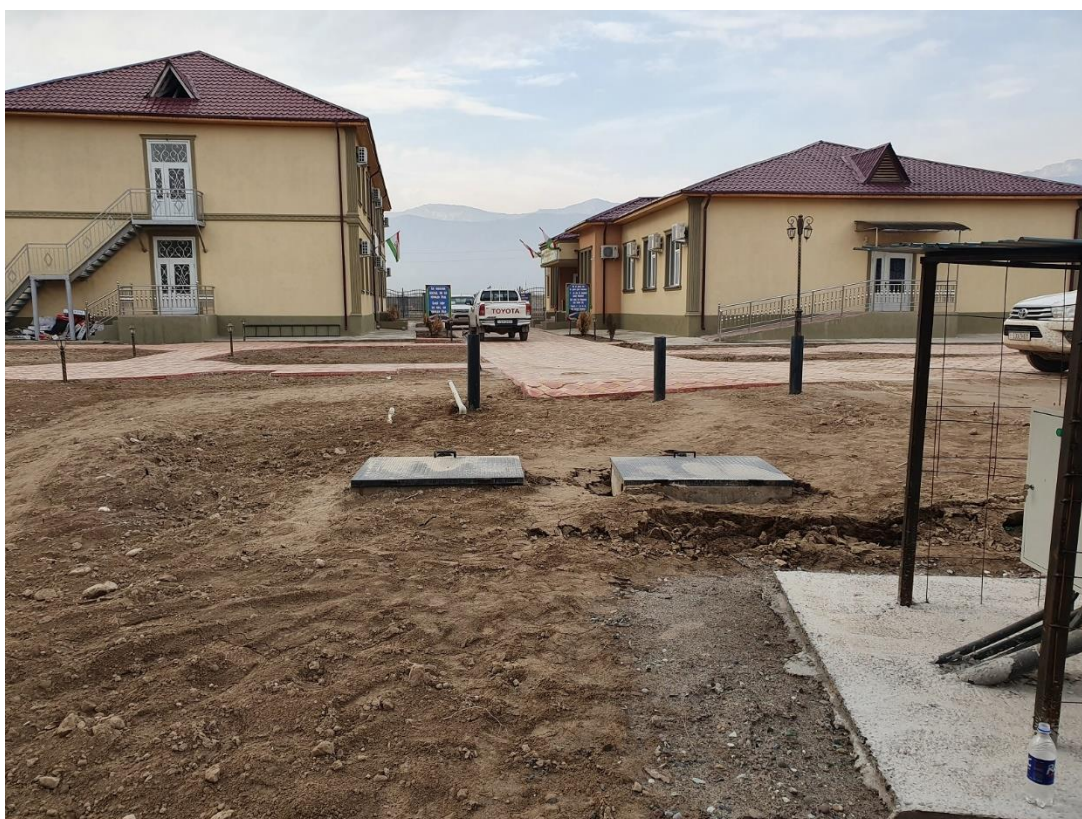
**Photo 3 New Engineer's office and accommodations buildings**

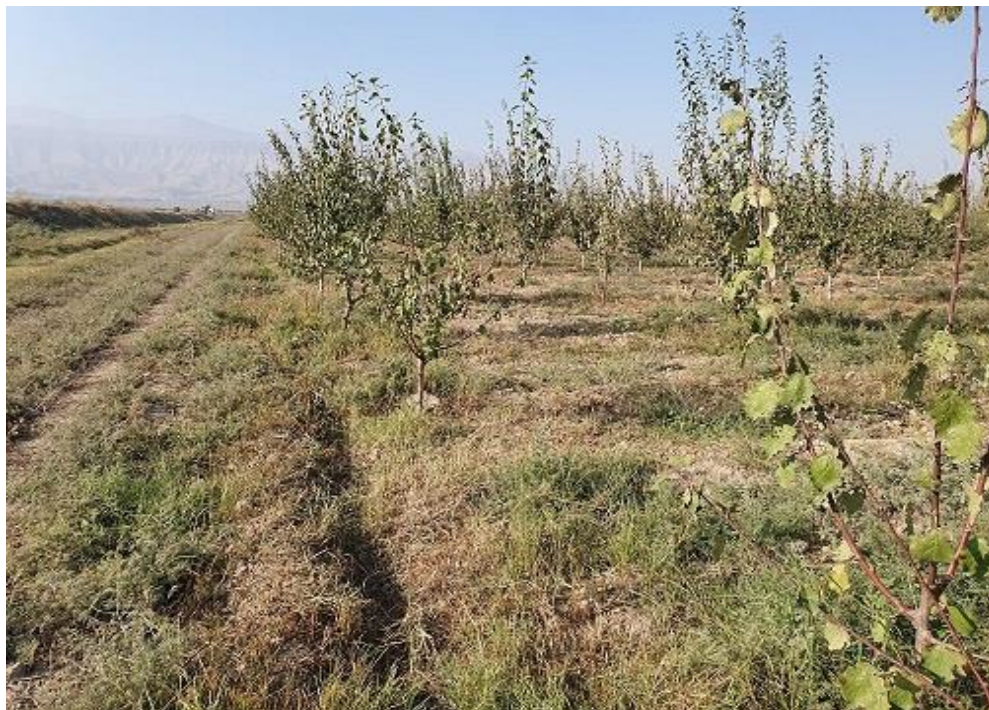
103. The felled trees have been delivered to the local road authority and distributed to schools and kindergartens as firewood. The private trees were given to the owners. The required approach here will be the replacement of removed trees. The Contractor should carry out the tree planting with 2 trees for 1 felled tree planted. This amount is determined by the Contract obligations of Contractor as a mitigation measure.
104. At the km 42-45 there are several dozens of fruit trees within the RoW of the project road. It was decided to relocate the trees instead of cutting. The beginning of the site clearance at these sections was postponed due to inappropriate season for re-planting. The relocation of trees is planned for January 2020.

**Photo 4 The fruit trees designated for relocation**

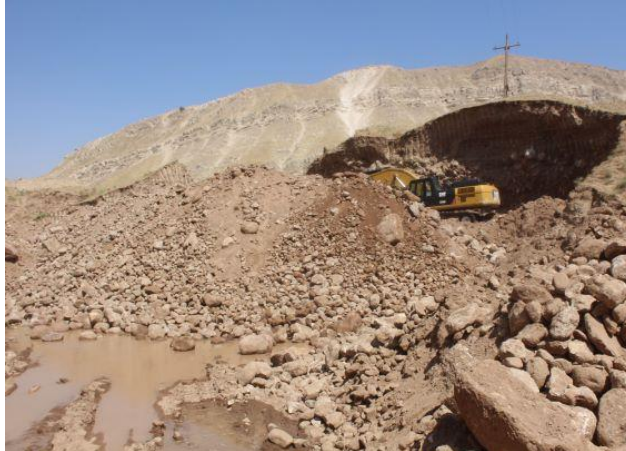
No	The Location of the Operational Quarry (Borrow Pit)	Environmental and Social Considerations
1	Km 37+200 (RHS)

<p>The extracted material was used for embankment, sub-base and capping layers at around km 33+475-38+900. The quarry operation partially disturbed the local drain, however the water is intermittent and used by the local community only for irrigation.</p>
2	Km 38+200 (LHS)

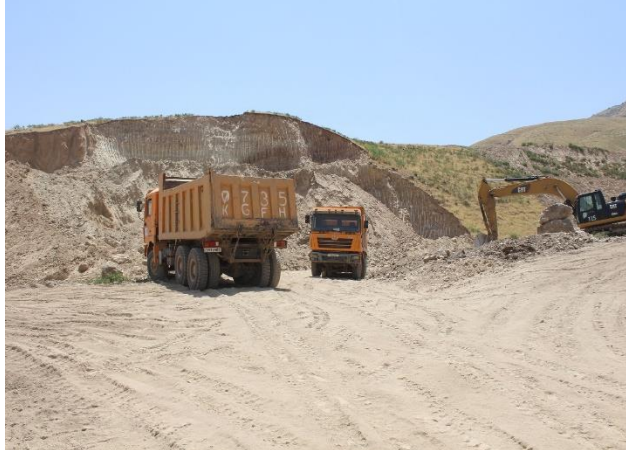
<p>The quarry is located on a slope in the vicinity of the road. No residential areas are nearby. The material was mainly used for backfilling of culverts and retaining walls around the sections between km 34+710 and km 38+095</p>
	Km55+100 (RHS) in 1 km from the road

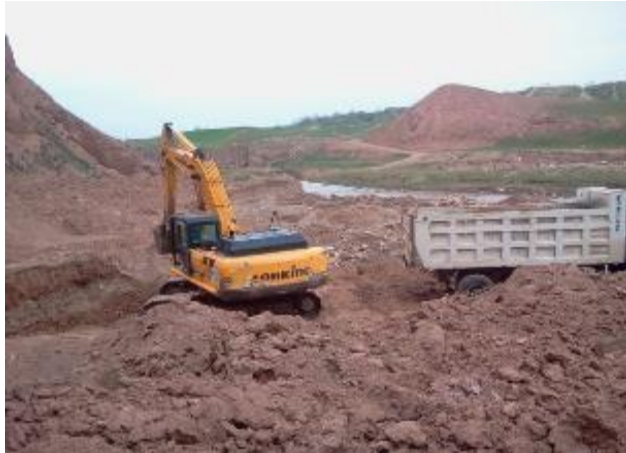
<p>The extracted material was mainly used for embankment and capping layers between km 52+000 to km 58+000. The diversion of the local stream was avoided and it was further protected by an earth berm.</p>
4	Km 66+100 RHS located in 2 km from the road

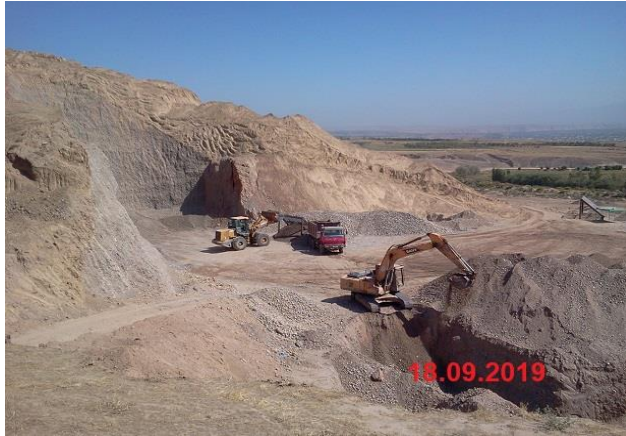
<p>The quarry is located in a hilly vacant area, with no water bodies in the vicinity of the quarry. The material from the quarry was used for the sub-base and capping layers between km 52+000 to km 56+000.</p>
5	Km 72+600(LHS)

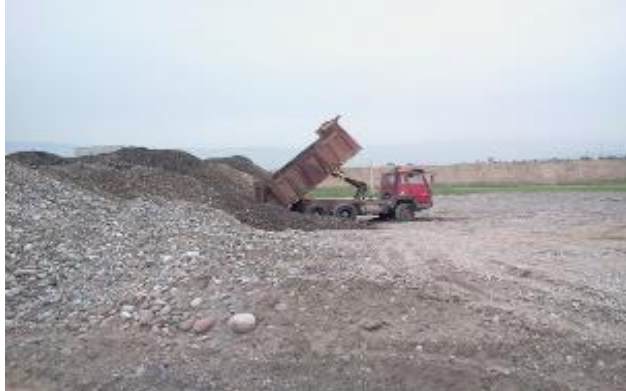
<p>The quarry provides material for two installed nearby crushing plants. Quarry is separated from the river channel by the gravel berm. No sensitive receptors are located in the vicinity of the site.</p>

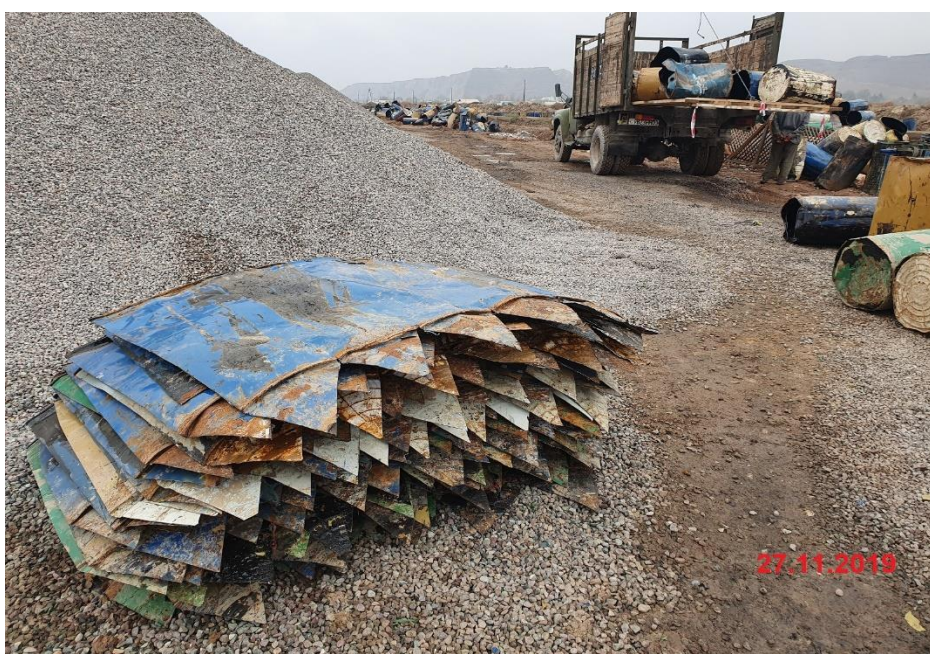
**Photo 5 Emptied bitumen drums nearby the asphalt plant prepared for utilization**

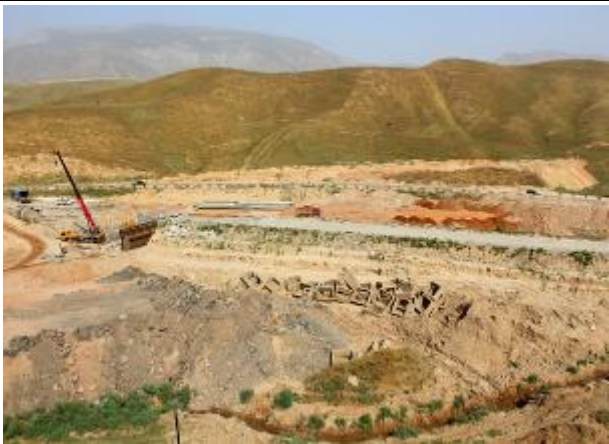
No	Site Location/ Photo	Environmental and social implications
1	km 33+500 LHS, RHS is given to Phase 1

View from the opposite slope. Contractor disposed the crushed asphalt on the top of excavated unsuitable material. The right side of the road has also been approved for disposal of unsuitable material.
2	km34+600 (LHS)

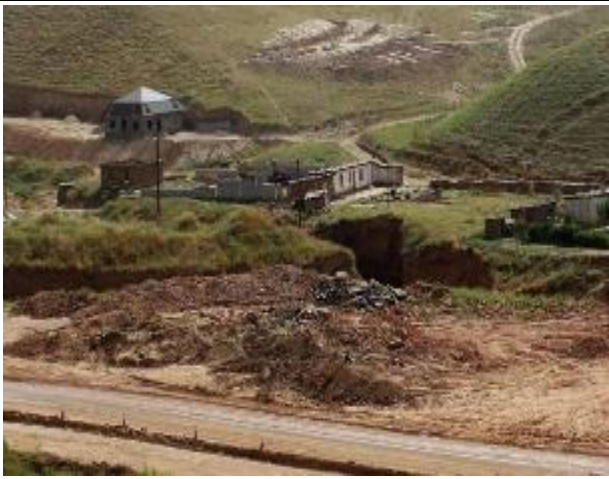
The disposal site is located from the left side of the road within the area of responsibility of road authority at the section km 34+300 – km 34+600. During the reporting period, the Contractor disposed unsuitable material excavated from km 34+800 – km 35+000 here.
3	km35+600 ( LHS)	
	 	Located at the left side of the project road at km 35+650. By agreement with the road-side restaurant owner, the Contractor used the unsuitable material from km 36+200 – km 36+400 for landscaping here.
4	Km 37+700

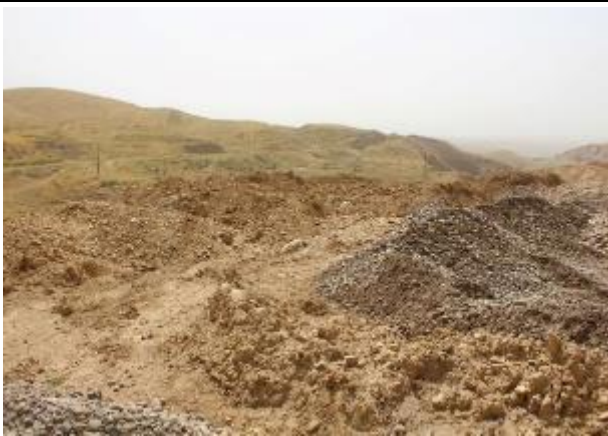
Located at the left side of the road at km 37+700, the site is also used for stockpiling of borrowed granular material. The levelling of the disposed material will be required here to reduce the landscape impacts.
5	Km 60+000

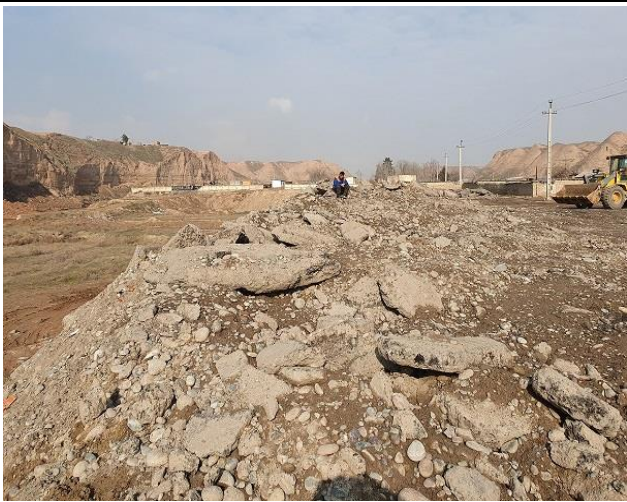
Located from the right side of the road in approximately 200m. The site is a local depression used by the locals as improvised landfill for garbage. Contractor uses the site for disposal of removed old asphalt. It is expected that material will be recycled and re-used by the local Road Authority in future/
	Km 67+000

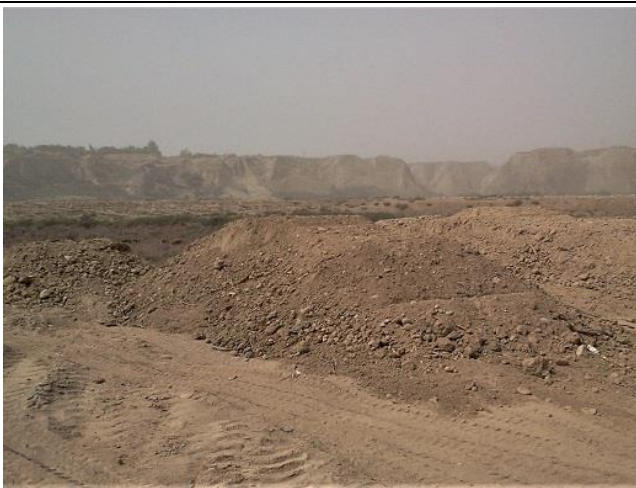
The disposal is allowed from the both sides of the road,

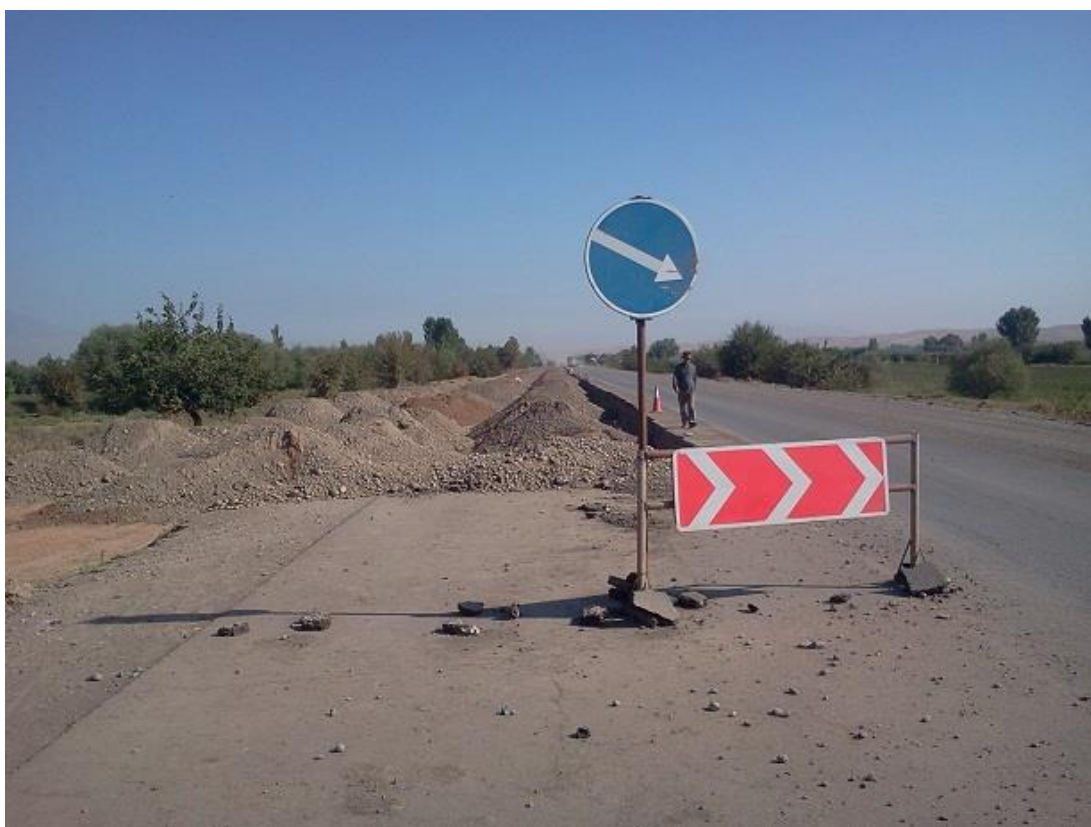
142. No community health and safety issues were reported during the monitoring period. Contractor generally provided adequate warning signage and fencing, however in some cases the separation of traffic and construction areas is not sufficient.

**Photo 8: The temporary signage is available but not always sufficient**

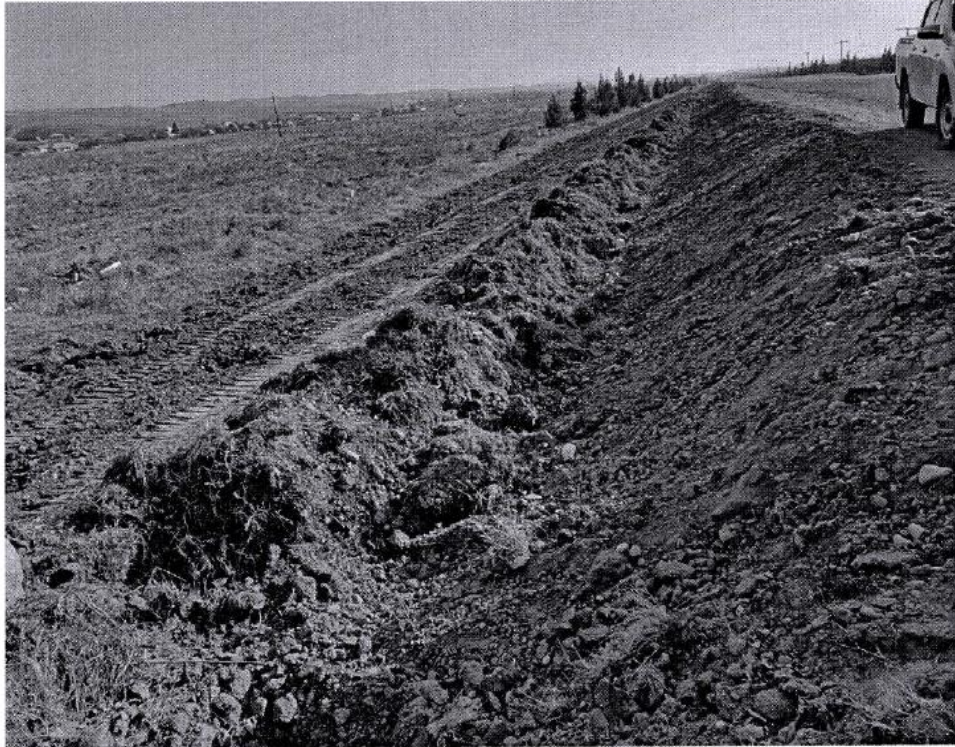
*Photo 1 The topsoil heaps along the road between Km 42+000-43+000*
