Project Number: Grant 0859-TAJ  
July 2025

Road Network Sustainability Project (Additional Financing).  
Semi-Annual Environmental Monitoring Report for  
January to June 2025.

Prepared by the Project Implementation Unit of Road Rehabilitation for the Ministry of Transport  
and the Asian Development Bank.

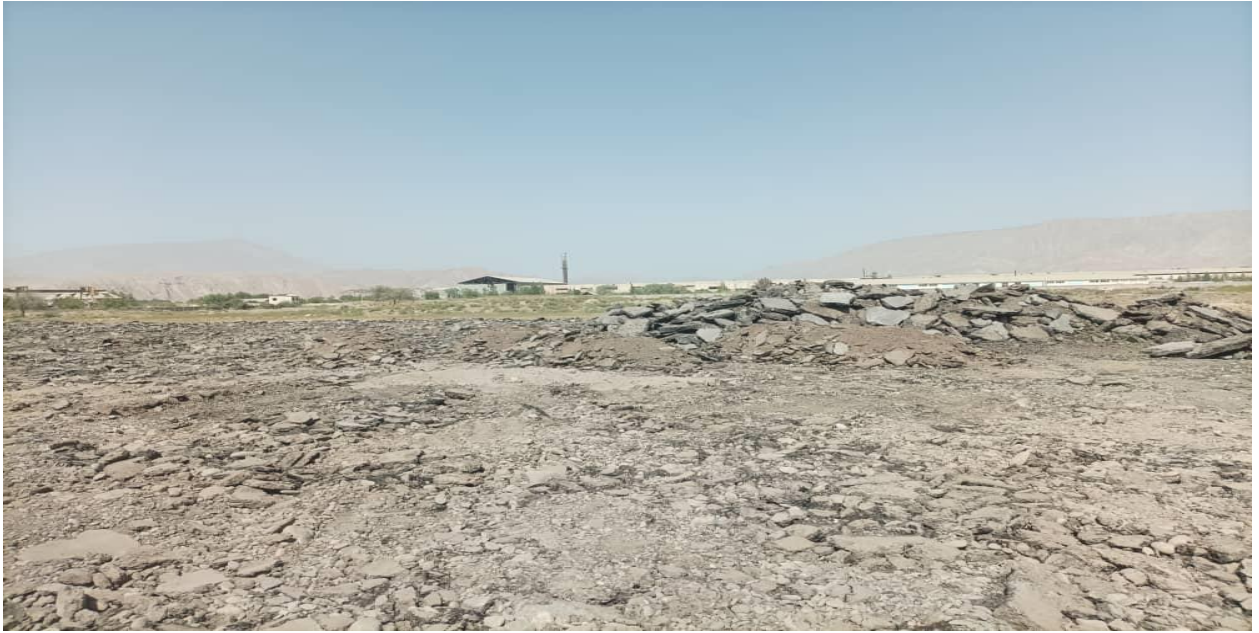
ПК 76+50 Отвал для хранения асфальт с левой стороны дороги. PK 76+50 Asphalt storage dump on the left side of the road.

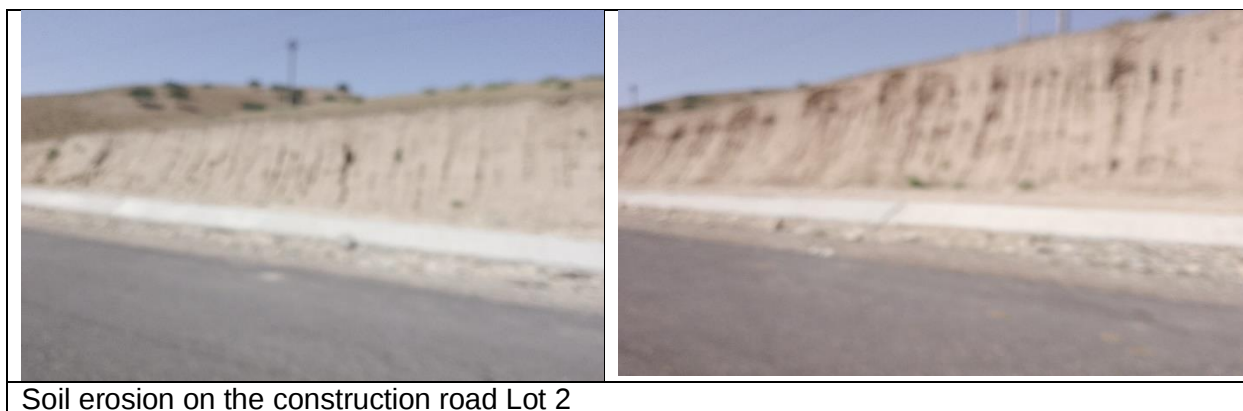
Soil erosion on the construction road Lot 2

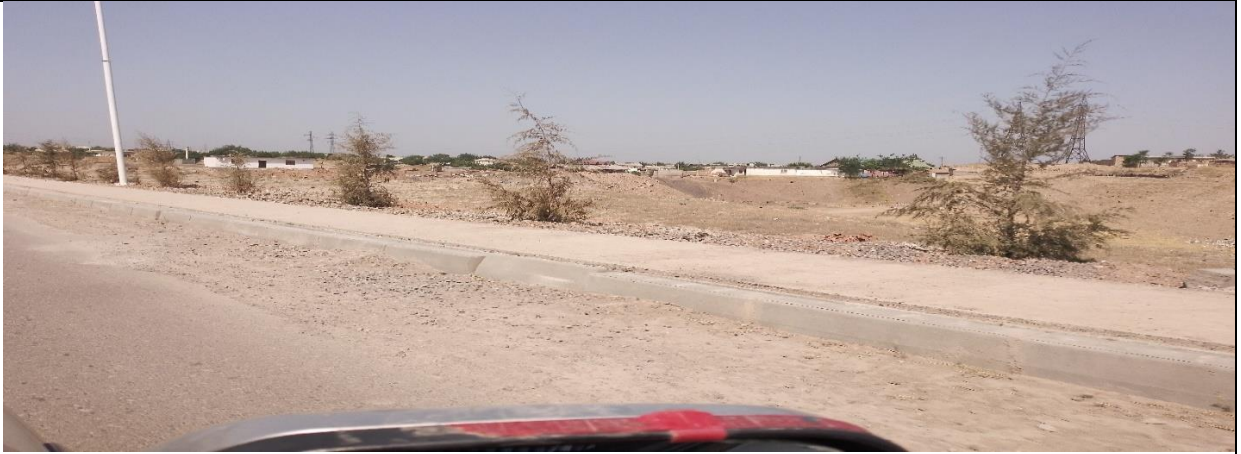
Dried trees at Lot 2

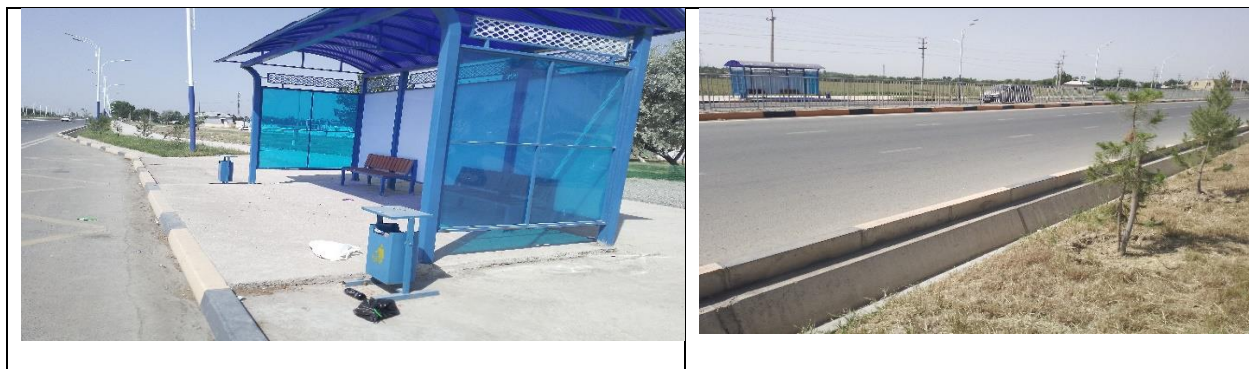
Stop, piranha fencing Lot -1.

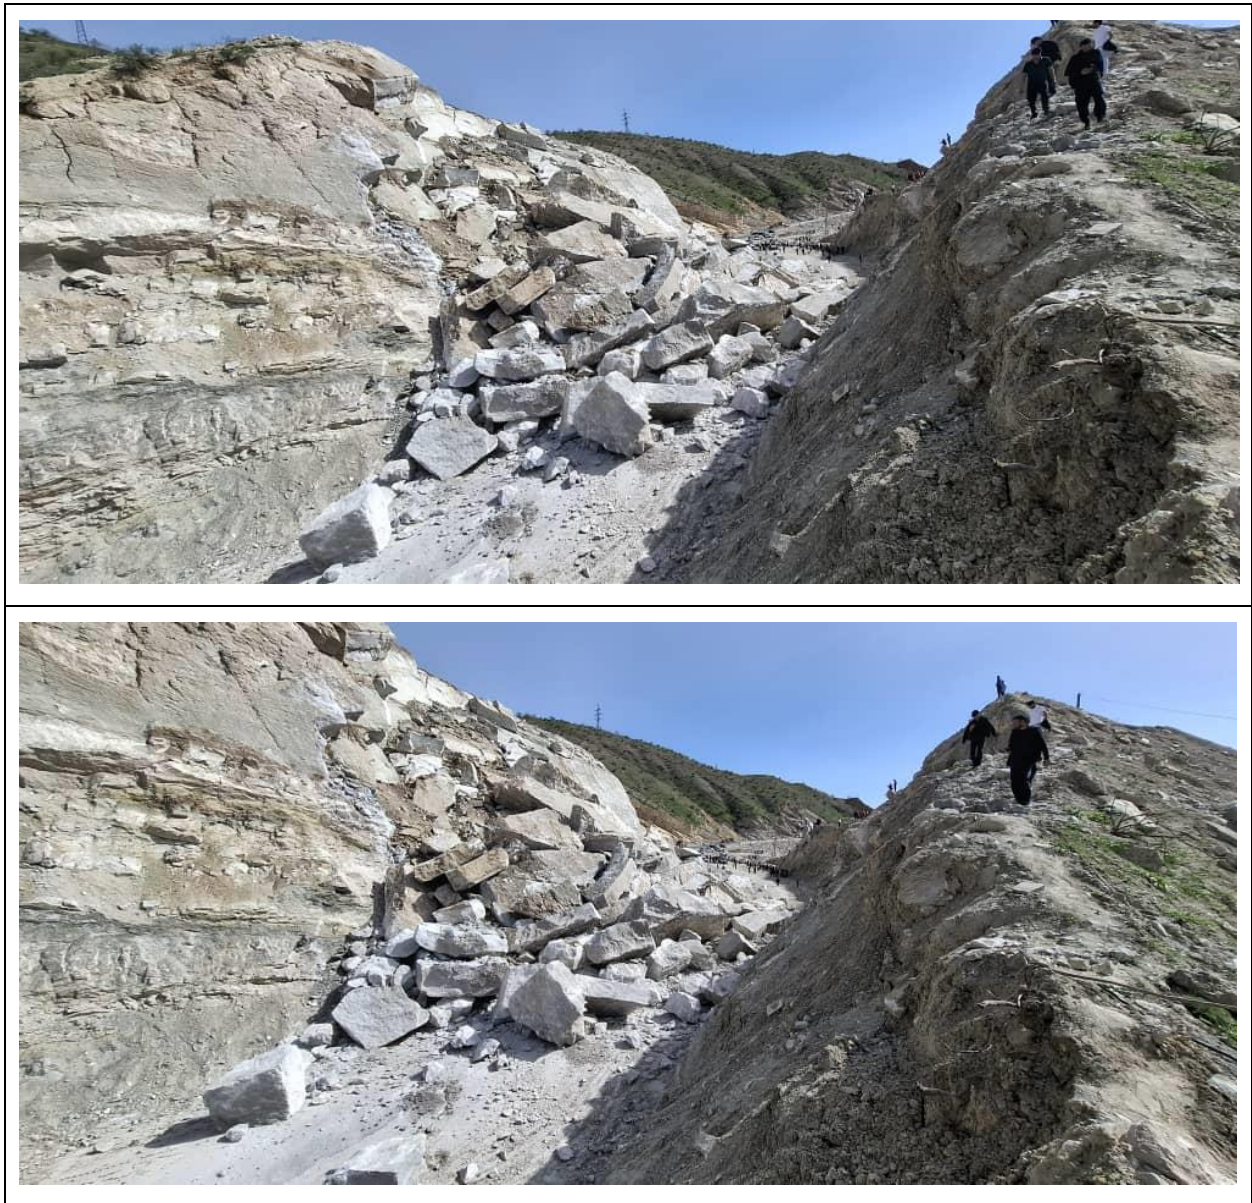
Figure 7 Slope Slide at km 186+40 to 187+40 /

In light of this we remind that at the landslide site it was recommended to make the slopes of the excavation walls (landslide site), the wall frills should be made as vertical as possible (according to the proposed design 1:0,5) and not to make the device of protective shelves to reduce the area of the slope from atmospheric precipitation, because at this site the rocks consist of heterogeneous soils at an angle of 20-60 degrees, which partially led to the landslide of fractured rocks. After completion of the rockslide site cleaning and shaping works, it is necessary to re-organize the works on observation of the excavation slope and backfilling of the roadbed during the warranty period (4-6 months) to restore the asphalt concrete pavement of the destroyed section of the road.

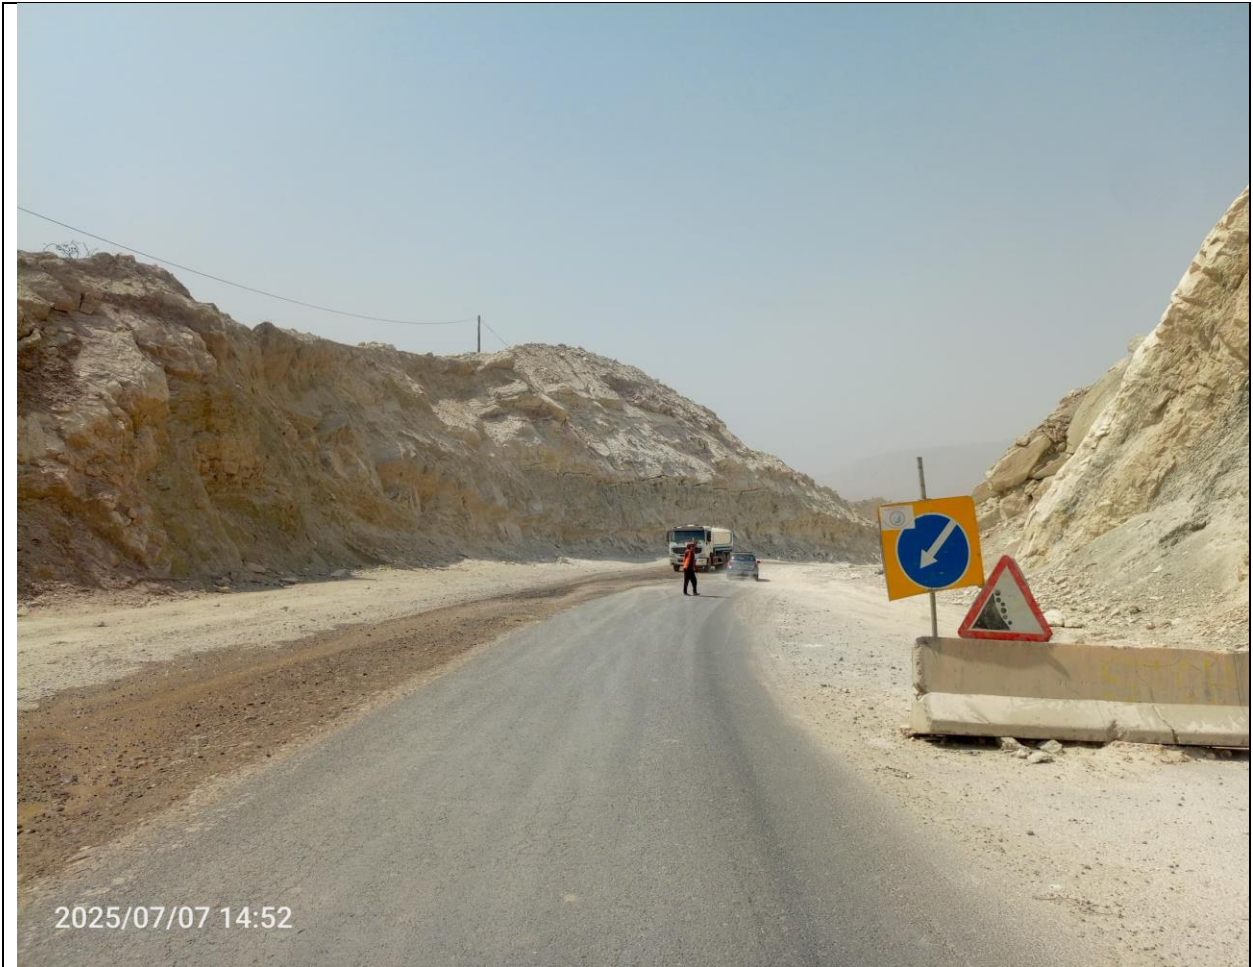
Performing works to eliminate collapse
