SEMI-ANNUAL ENVIRONMENTAL MONITORING REPORT

Reporting period: January-June 2020

Republic of Tajikistan: CENTRAL ASIA ECONOMIC COOPERATION CORRIDORS 2, 5, and 6 (DUSHANBE – KURGONTEPPA) ROAD PROJECT - Additional Financing

Prepared by Kocks Consult GmbH; Germany for the Ministry of Transport of the Republic of Tajikistan and the Asian Development Bank

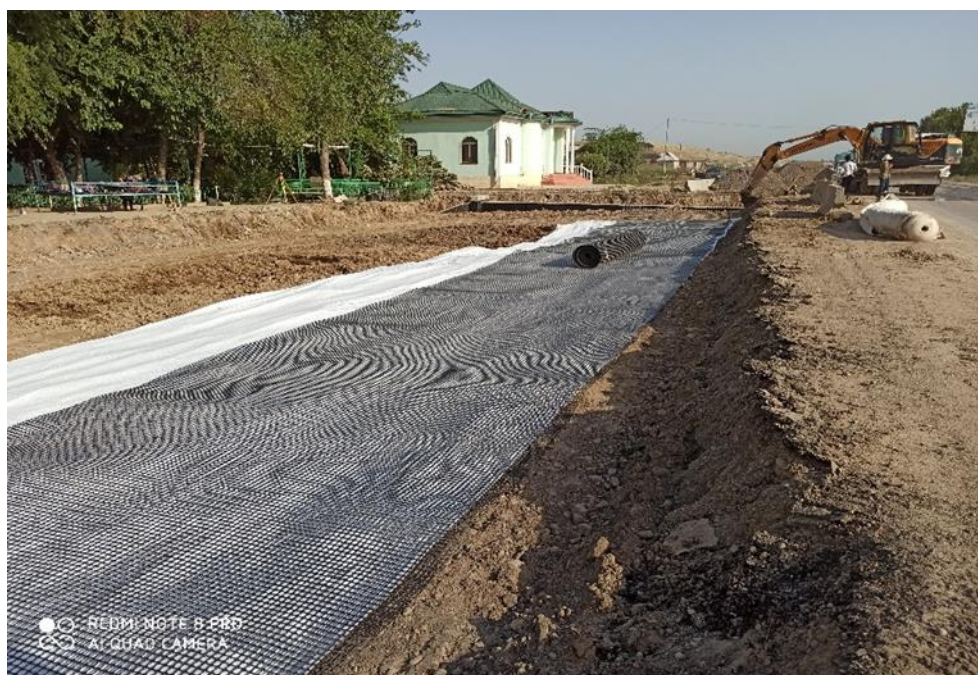
Photo 1 The placing of geotextile and geogrid at Km 49+590(photo taken in June 2020)

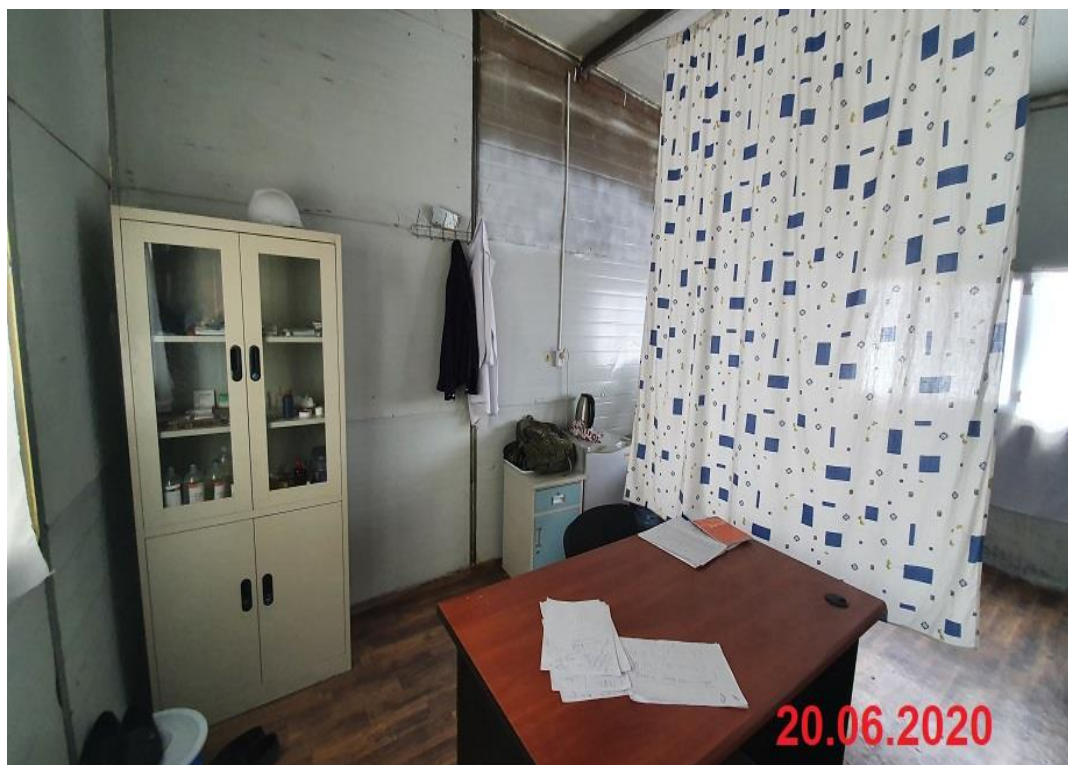
Photo 3: The equipped first aid room in the Camp of Contractor (taken in June 2020)

89. During the reporting period the COVID-19 pandemic became the most significant health issue, in various ways affecting the project performance.
90. The contractor properly equipped the first aid room at the main work camp and hired a professional paramedic to coordinate the health issue and provide the first aid in cases of an emergency. The paramedic coordinates and conducts regular examinations of the staff and coordinates with external health facilities if necessary. In addition the first aid station.

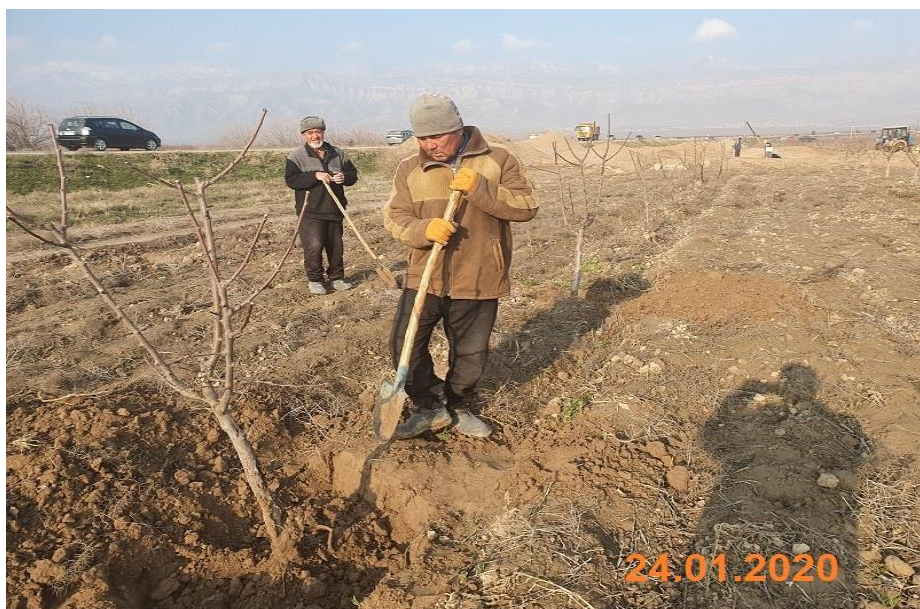
106. Between km 42-45 there are several dozens of fruit trees within the RoW of the project road. It was decided to relocate the trees instead of cutting. The beginning of the site clearance at these sections was postponed due to inappropriate season for re-planting. The relocation of the trees was performed during appropriate season in January 2020.

Photo 4 The relocation of immature fruit trees within the RoW at km 43+500(taken in January 2020)

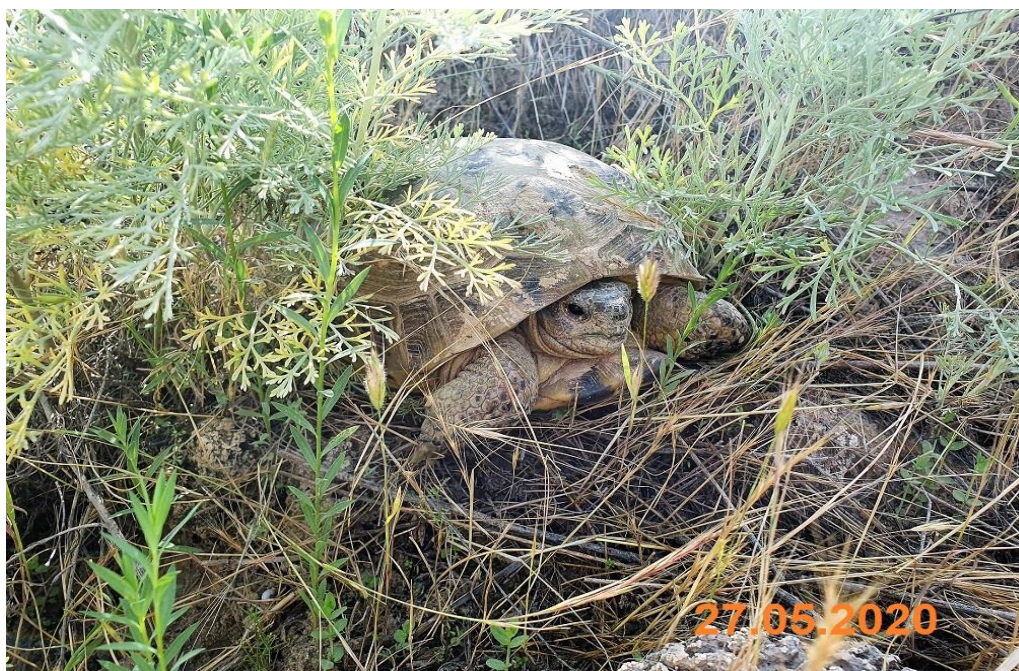
108. For example the endangered steppe tortoise (*Agrionemys horsfieldii*) was found nearby the beginning of the project (photo 5). At the construction sites the workers were instructed to avoid damaging any wild species. The observed tortoise was separated from the construction activities by the stream that ensured the safety of habitat. No other endangered or valuable species have been identified by the ES. No other endangered or valuable species have been identified in the Project influence zone during the monitoring period.

Photo 5 The steppe tortoise in the shrubs nearby the Km 35+000 of the Project Road (taken in May 2020)

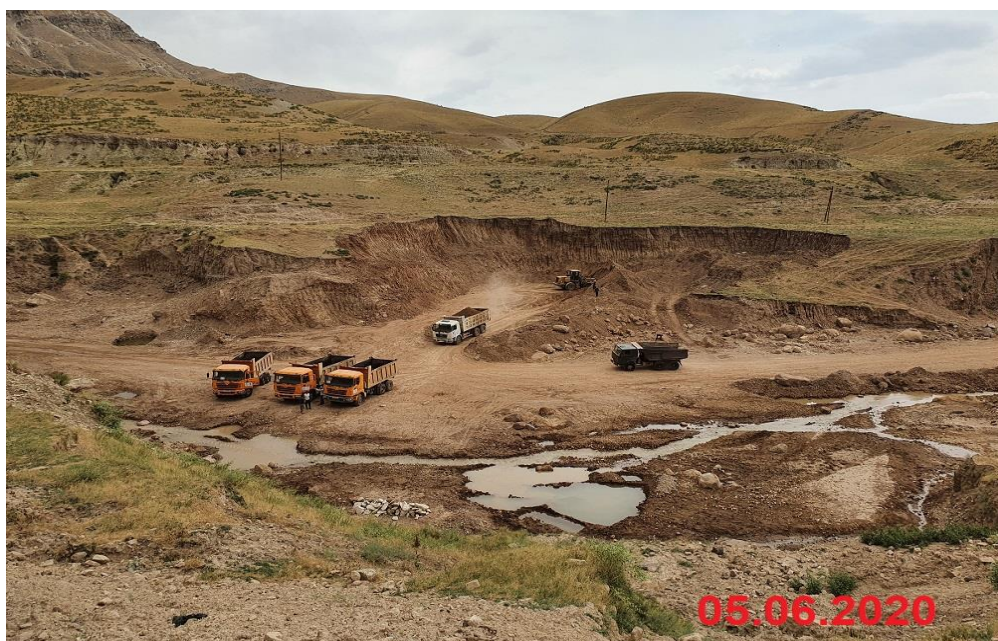
Photo 7 Operating quarry at km 37+200(LHS) (taken in June 2020).

No	The Location of the Operational Quarry (Borrow Pit)	Environmental and Social Considerations
1	Km 37+200 (LHS)	The extracted material was used for embankment, sub-base and capping layers at around km 33+475-38+900. The quarry operation conducted nearby the local drain (Photo5), however the drain is seasonal and used by the local community only for irrigation.
2	Km 38+200 (LHS)	The quarry is located on a slope in the vicinity of the road. No residential areas are nearby. The material was mainly used for backfilling of culverts and retaining walls around the sections between km 34+710 and km 38+095
3	Km55+100 (RHS) in 1 km from the road	The extracted material was mainly used for embankment and capping layers between km 52+000 to km 58+000. The diversion of the local stream was avoided and it was further protected by an earth berm.
4	Km 66+100 RHS	The quarry is in a hilly vacant area, with no water

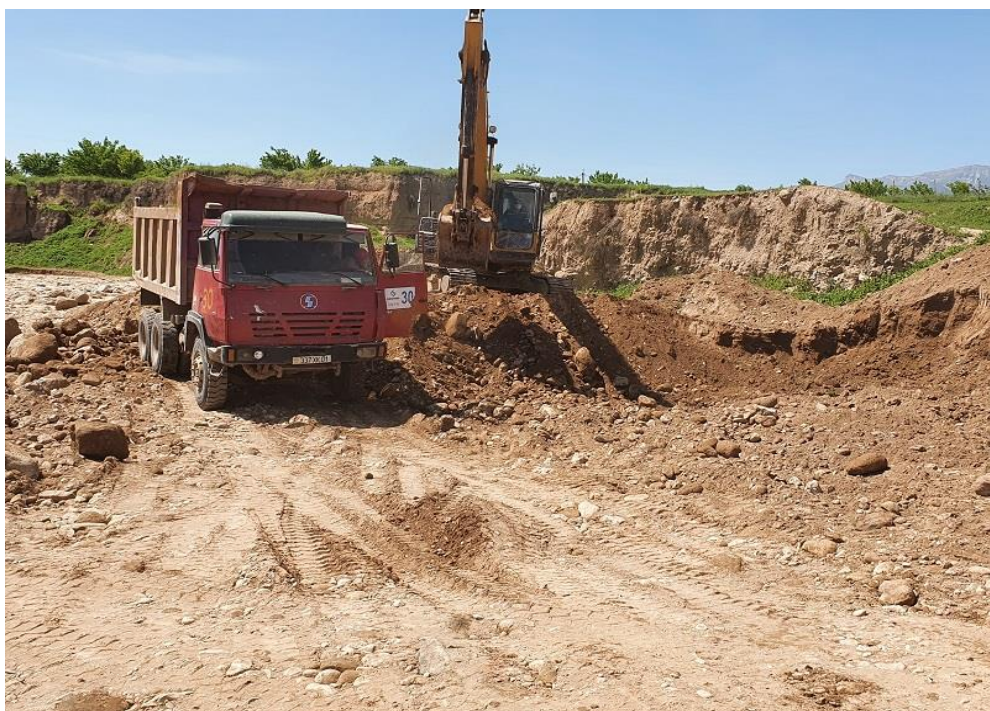
Photo 8 Excavation of material for construction of embankment for the quarry on Km42+100(LHS) (taken in April 2020)

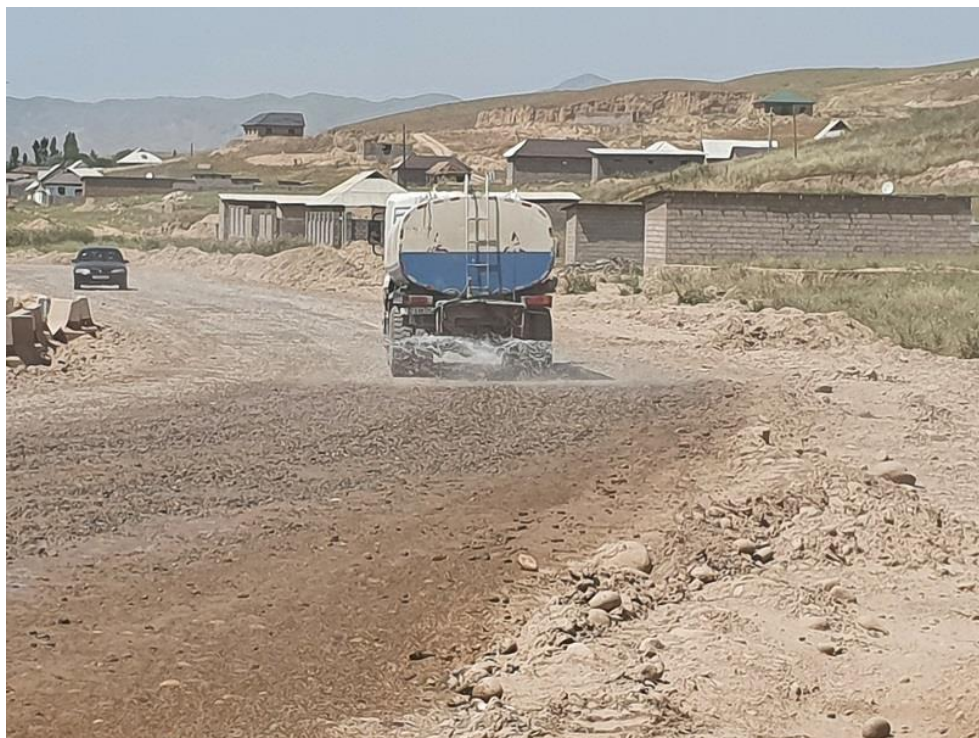
Photo 24 Spraying of water on the bypass road at Km 50+000 (May 2020)
