Project Number: Grant 0859-TAJ  
July 2025

Road Network Sustainability Project (Additional Financing).  
Semi-Annual Environmental Monitoring Report for  
January to June 2025.

Prepared by the Project Implementation Unit of Road Rehabilitation for the Ministry of Transport  
and the Asian Development Bank.

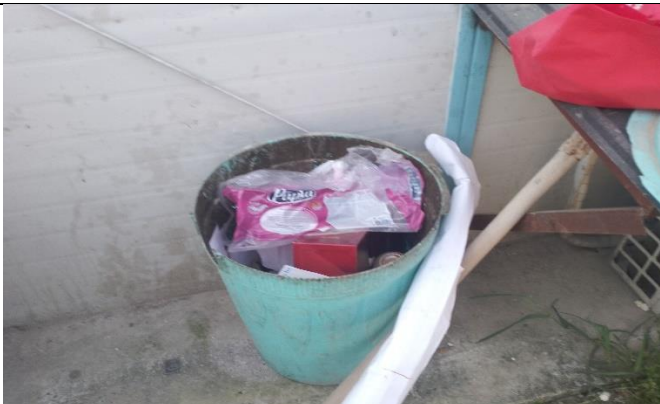
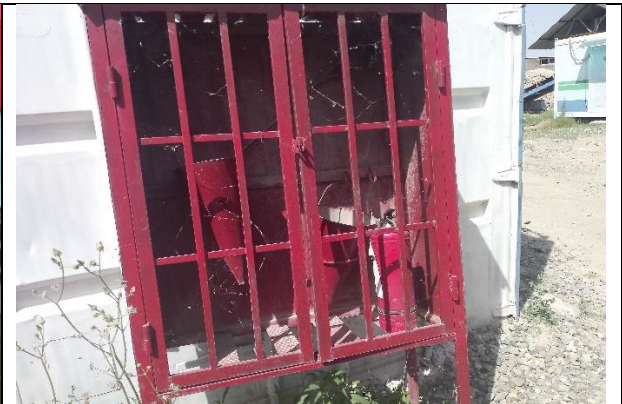
Undecent construction waste in the camp both objects

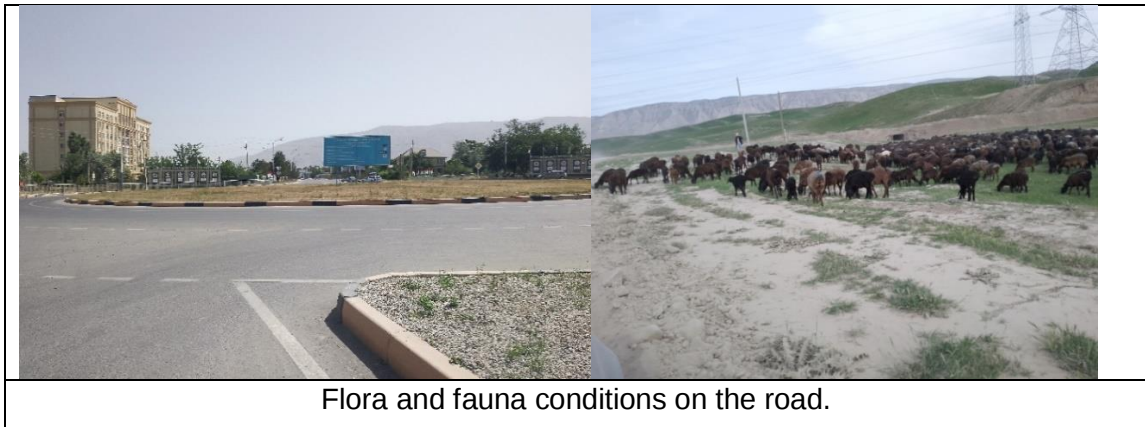
Flora and fauna conditions on the road.

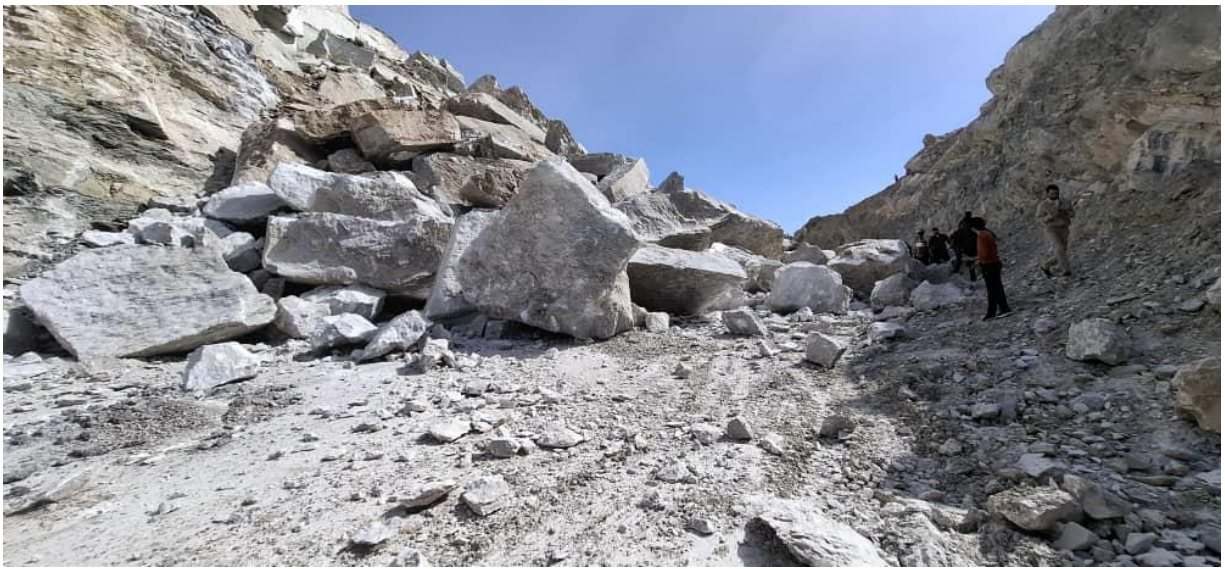
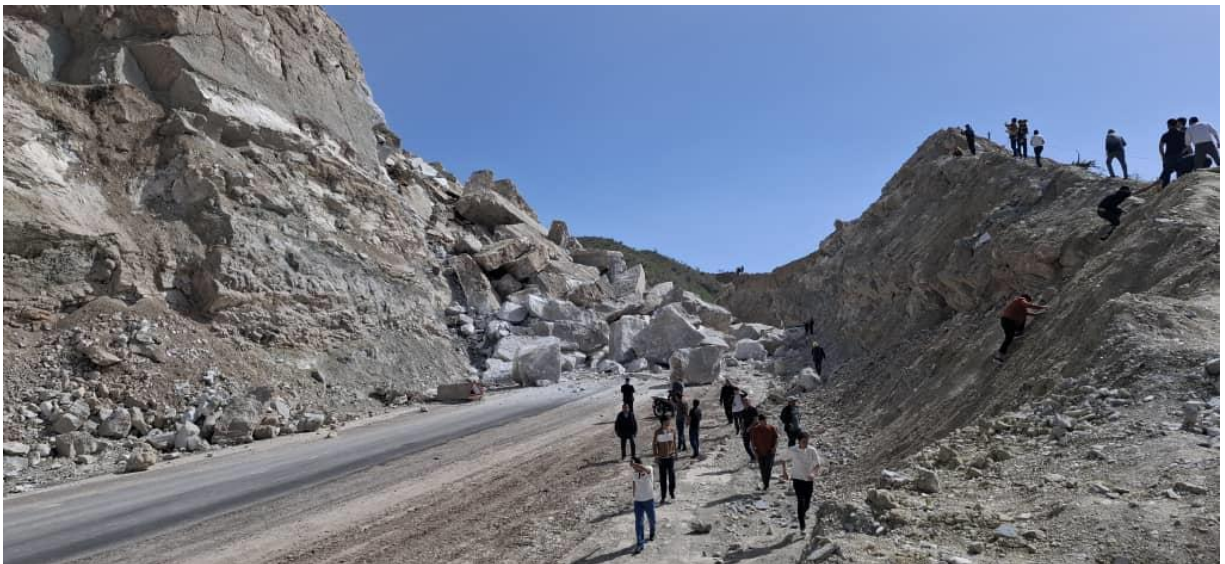
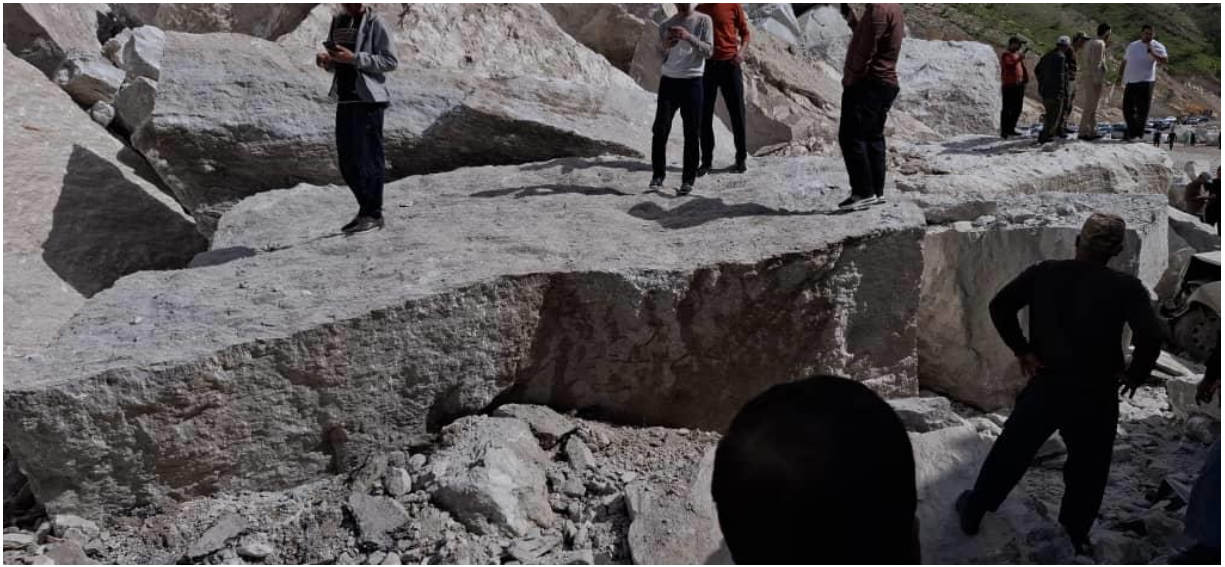
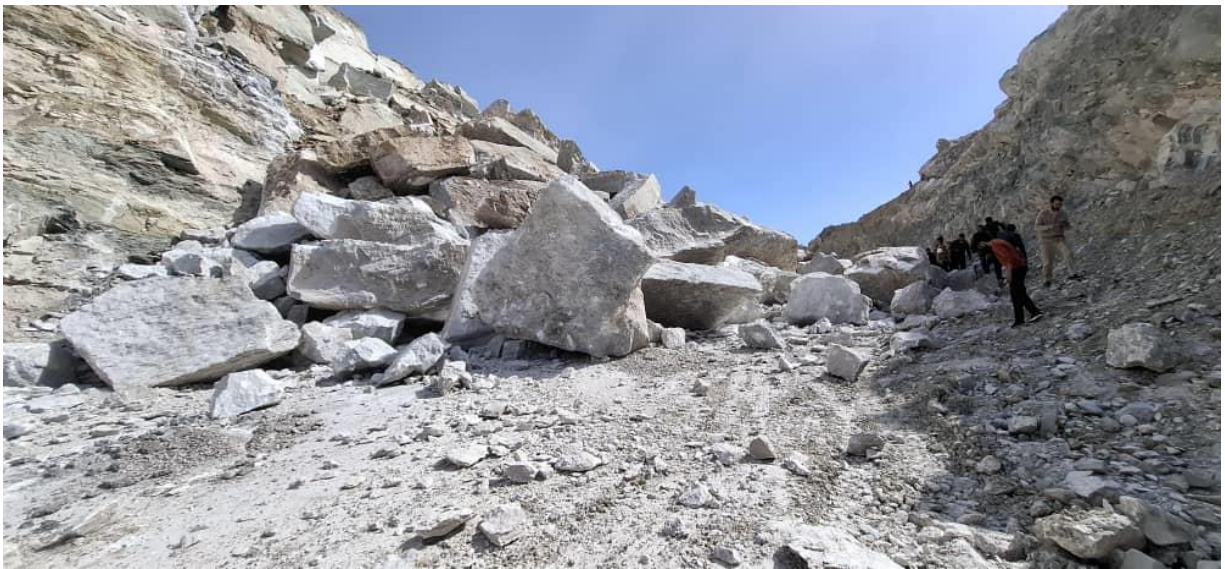
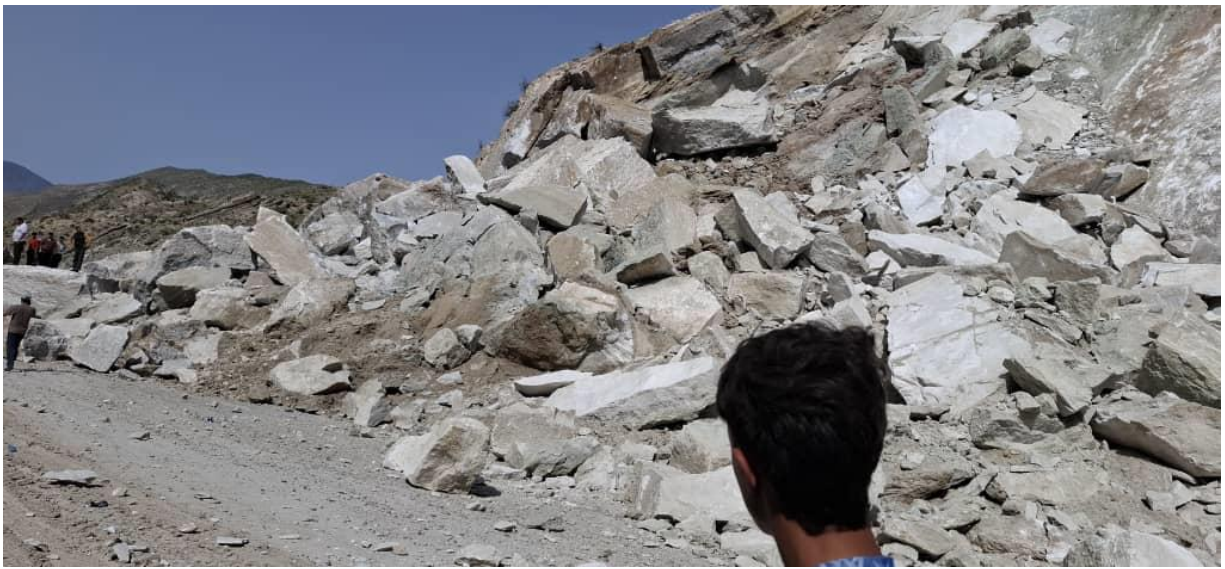
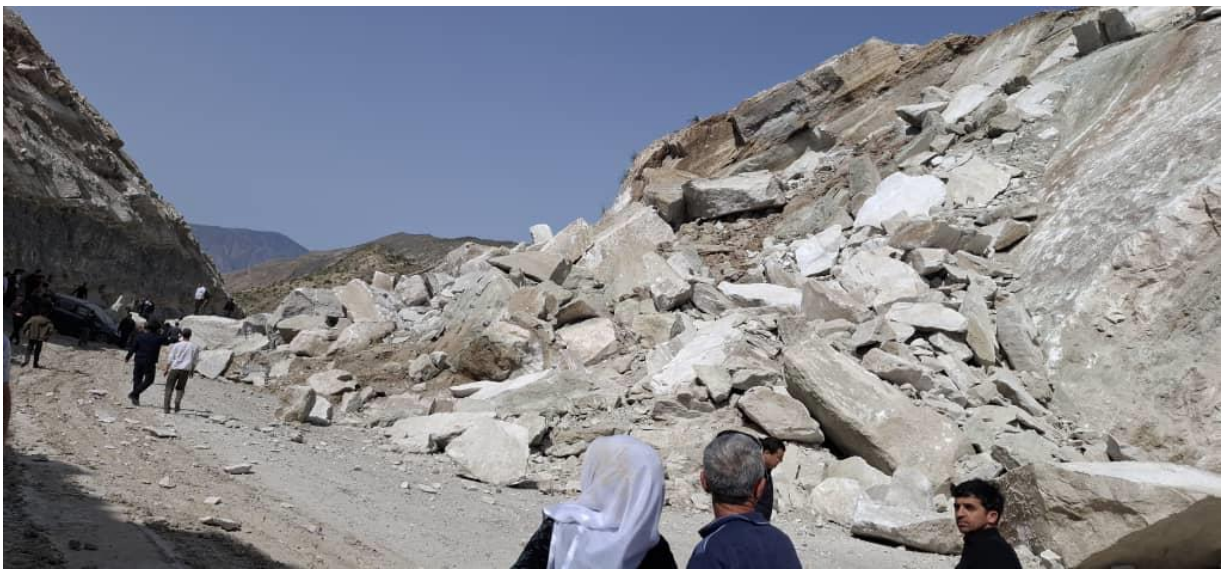
*Figure 8 Victims evacuation by Emergency Staff*

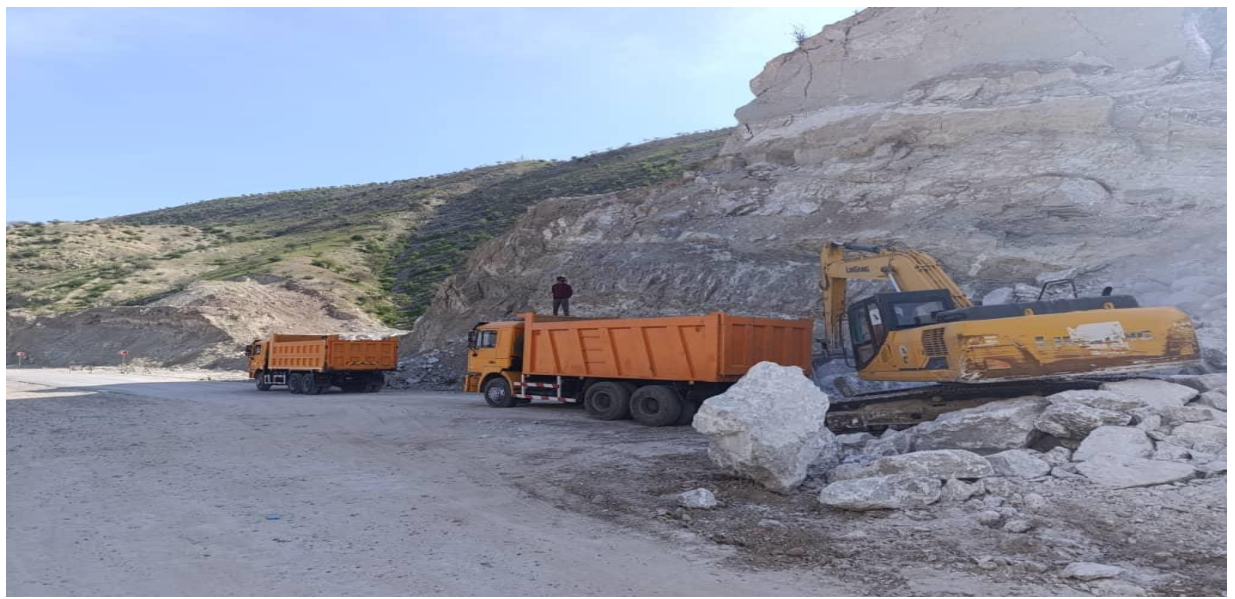
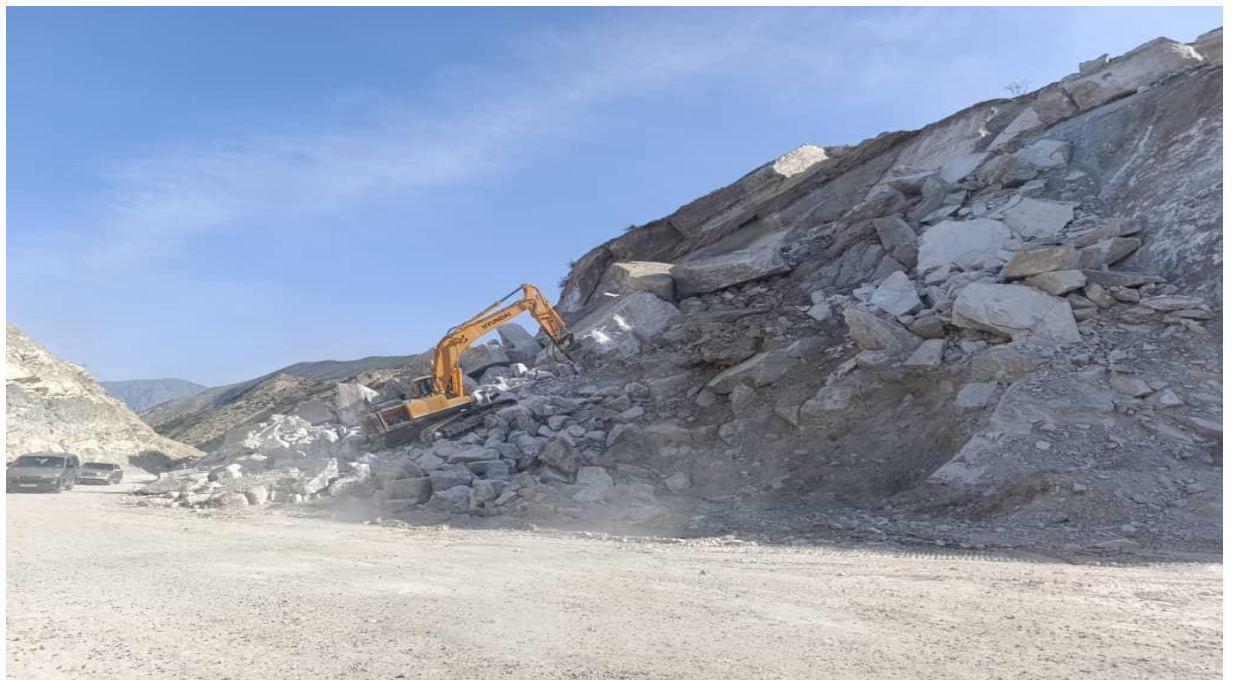
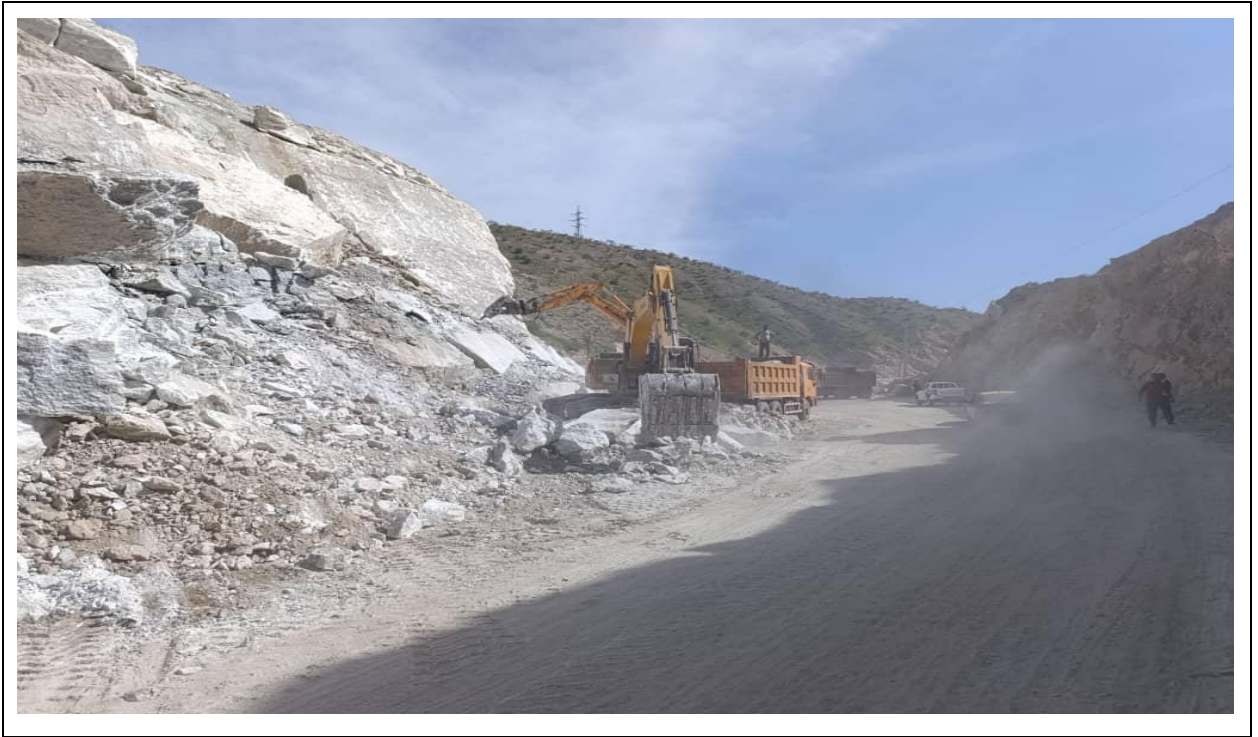
The Engineer had visited the site of Lot 2 on 1<sup>st</sup>, 3<sup>rd</sup>, 9<sup>th</sup>, 18<sup>th</sup>, 23<sup>rd</sup>, 25<sup>th</sup>, and 29<sup>th</sup> April 2025 was in touch with the Supervision Consultant staff permanently present at site. Daily Work Progress reports are sent to the Client, Engineer, which confirm the fact that the maximum amount of fallen rock and debris has been cleared from the damaged section of the road and taken to the dumping area, which allows two-way traffic movement. The flag men are controlling the traffic continuously during the clearance of the remaining debris from the road. The Contractor has mobilized the number of the equipment to the damaged section and currently 2 Excavators, 1 hydraulic hammer and 2 Loaders, 4 Dump trucks are operating.

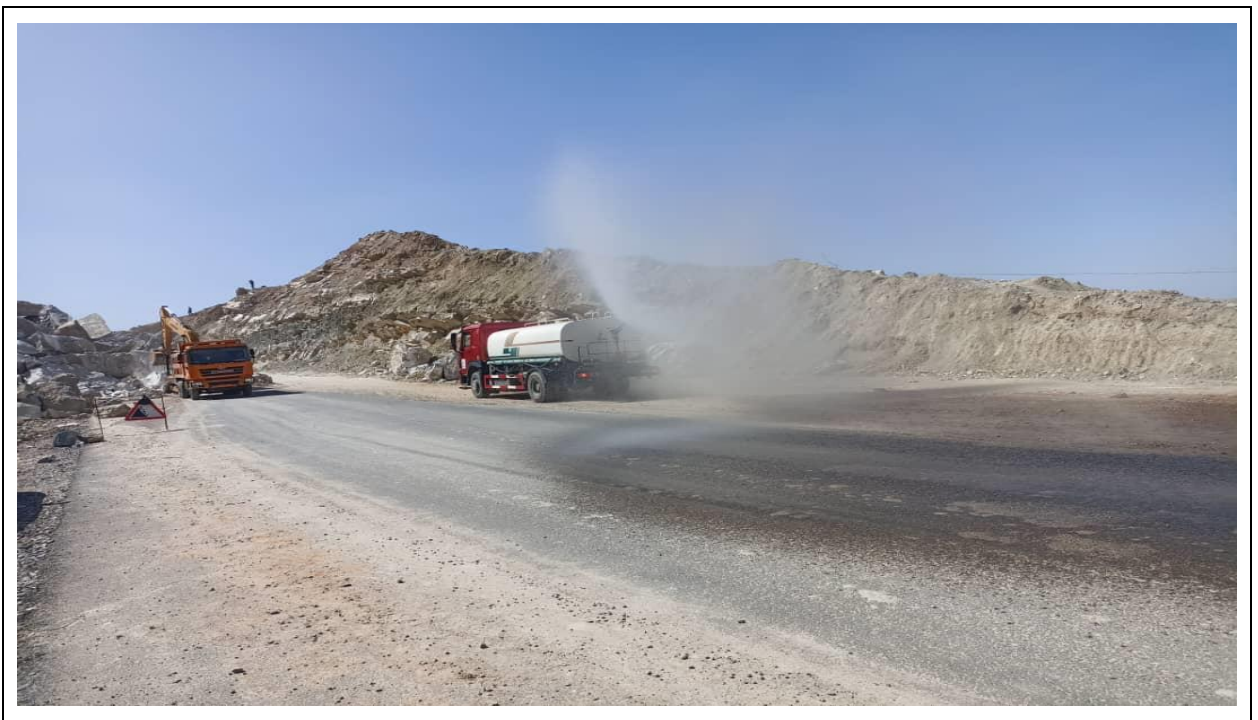
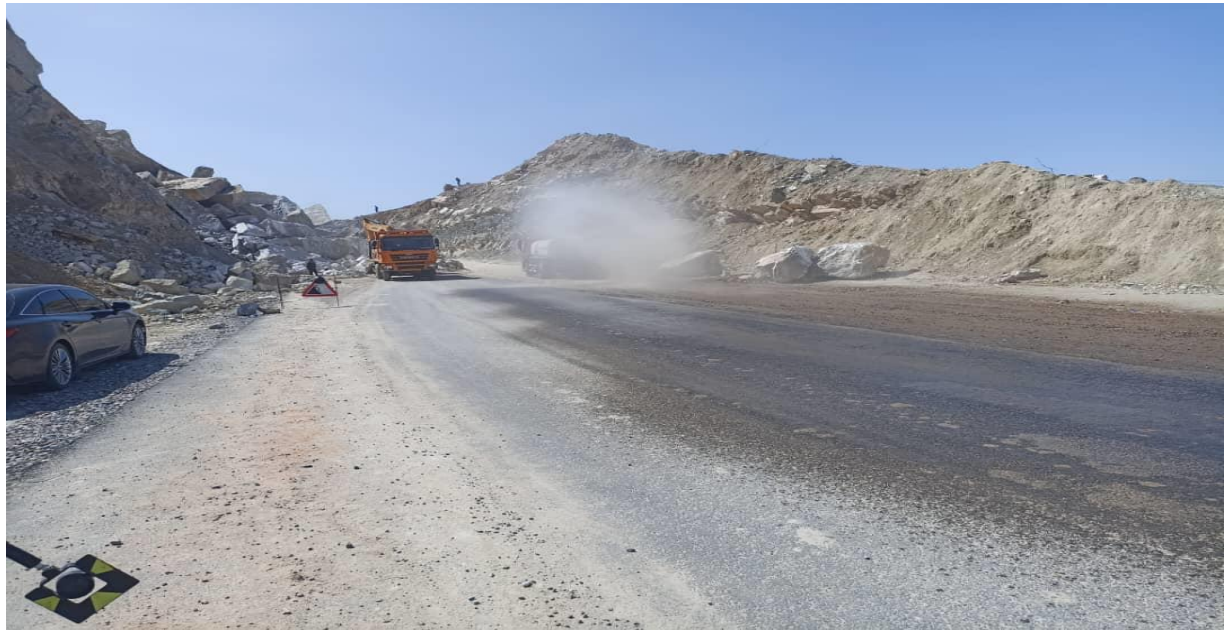
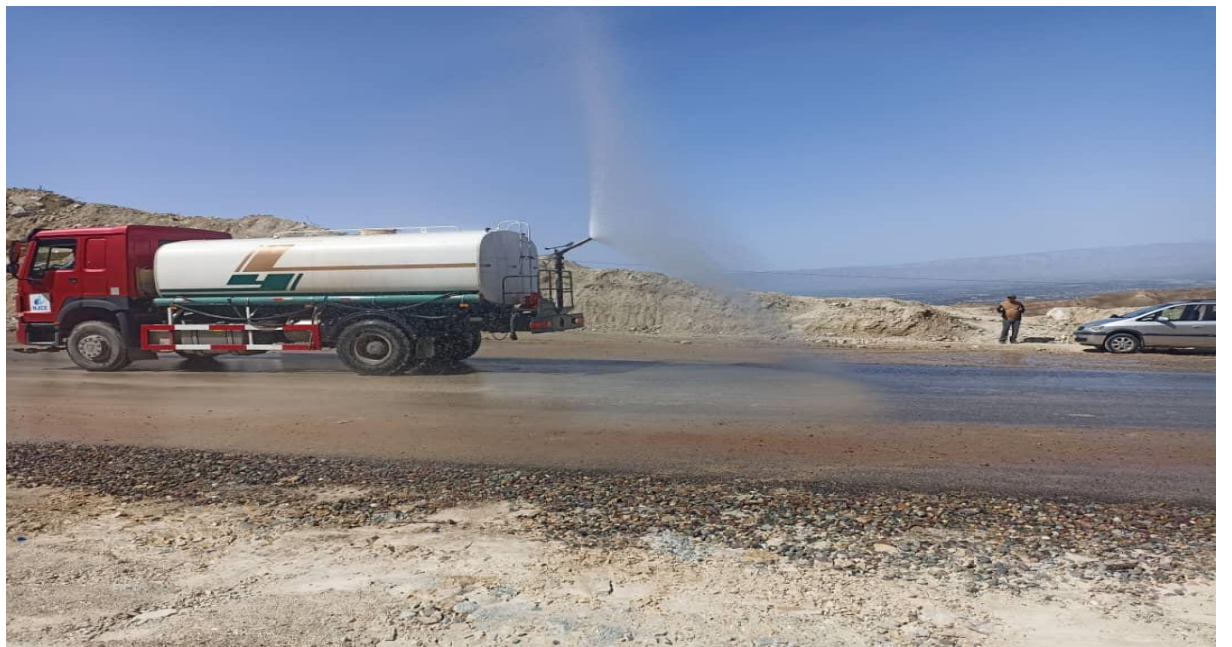
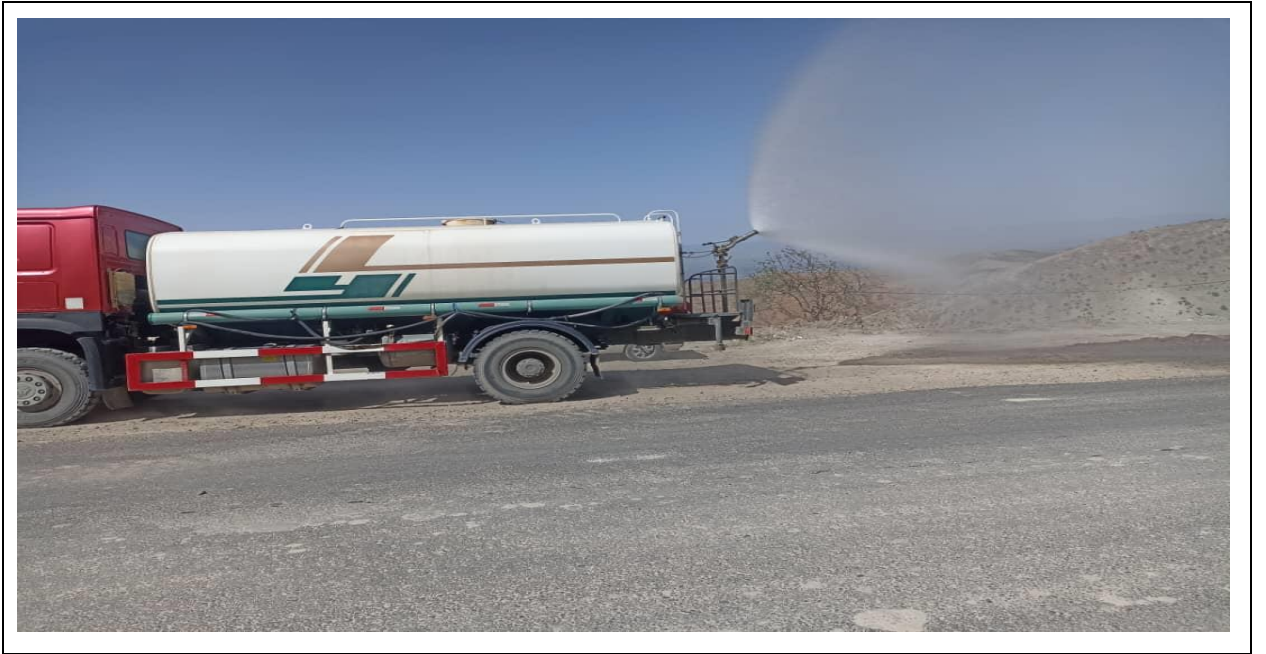
Regarding site safety arrangements, it should be noted that a water sprinkler is continuously watering the damaged section to suppress dust during the work. Road safety warning signs have been installed on both sides of the road, two flagmen are controlling the traffic, safety tapes have been placed in the affected area to warn drivers to take a safer direction, and the workers have been consulted on safety measures.

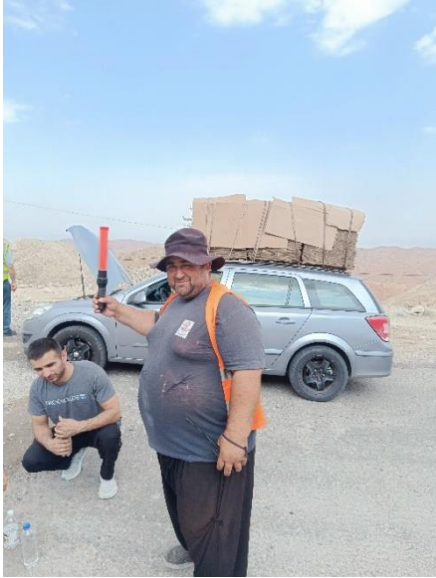
| 5. Initial brief Action Plan: short, mid and long-term actions<br>(detailed and extended Action Plan to be included in the revised incident report) | | | | |
|---|---|---|---|---|
| 1 | To keep the installed advisory signages warning drivers not to enter the area due to potential danger. | <b>Constantly</b> | MOT/PIURR | <p>The warning signs have been installed in place and the damaged section is being controlled by flag men.</p> |

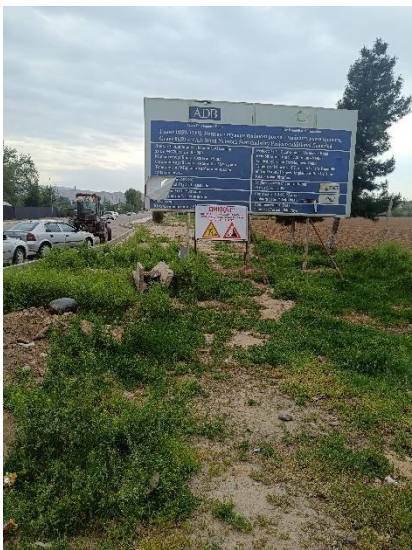
| 5. Initial brief Action Plan: short, mid and long-term actions<br>(detailed and extended Action Plan to be included in the revised incident report) | | | | |
|---|---|---|---|---|
| 2 | The warning signs shall be relocated closer to the road, to be more visible for the road users (ref. photos on pages 14 -16 in the Attachment 1. The warning signs is a white colored rectangle with an approximate L * W size of 2 m * 1.5 m located on the | <b>ASAP</b> | MOT/PIURR | <p>The sign location has been adjusted to improve visibility.</p> |

| | right side of the road/pedestrian area). | | | See below latest Photo:<br> |

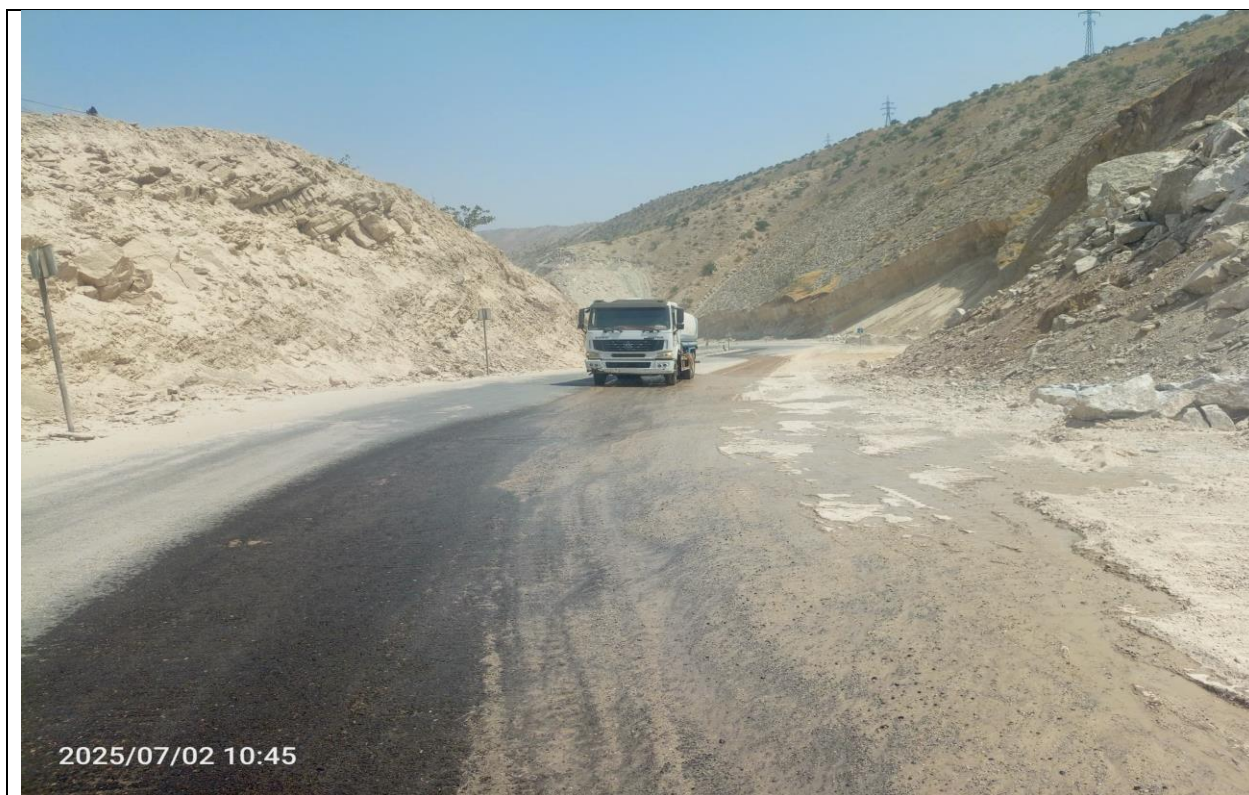
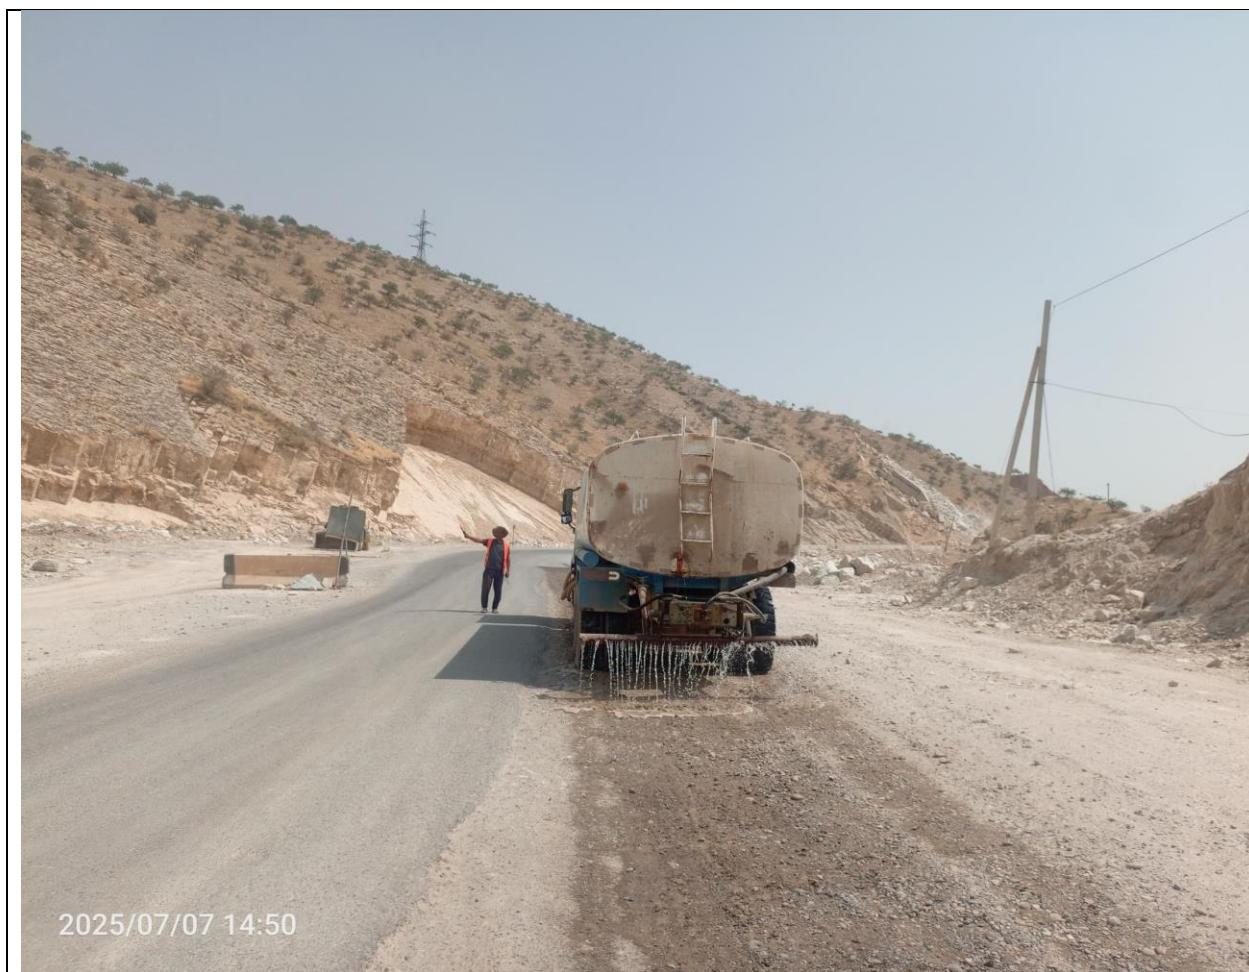
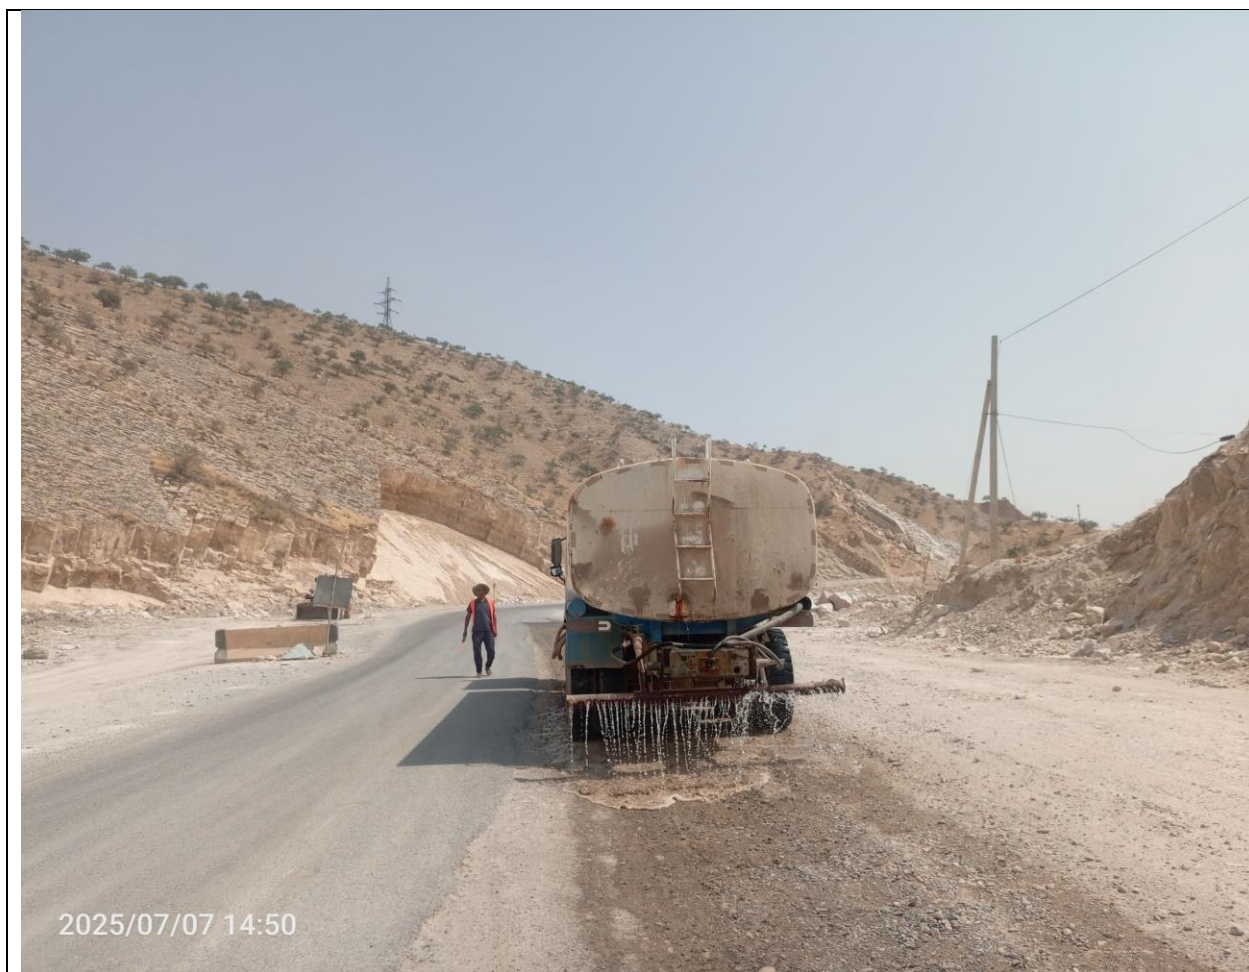
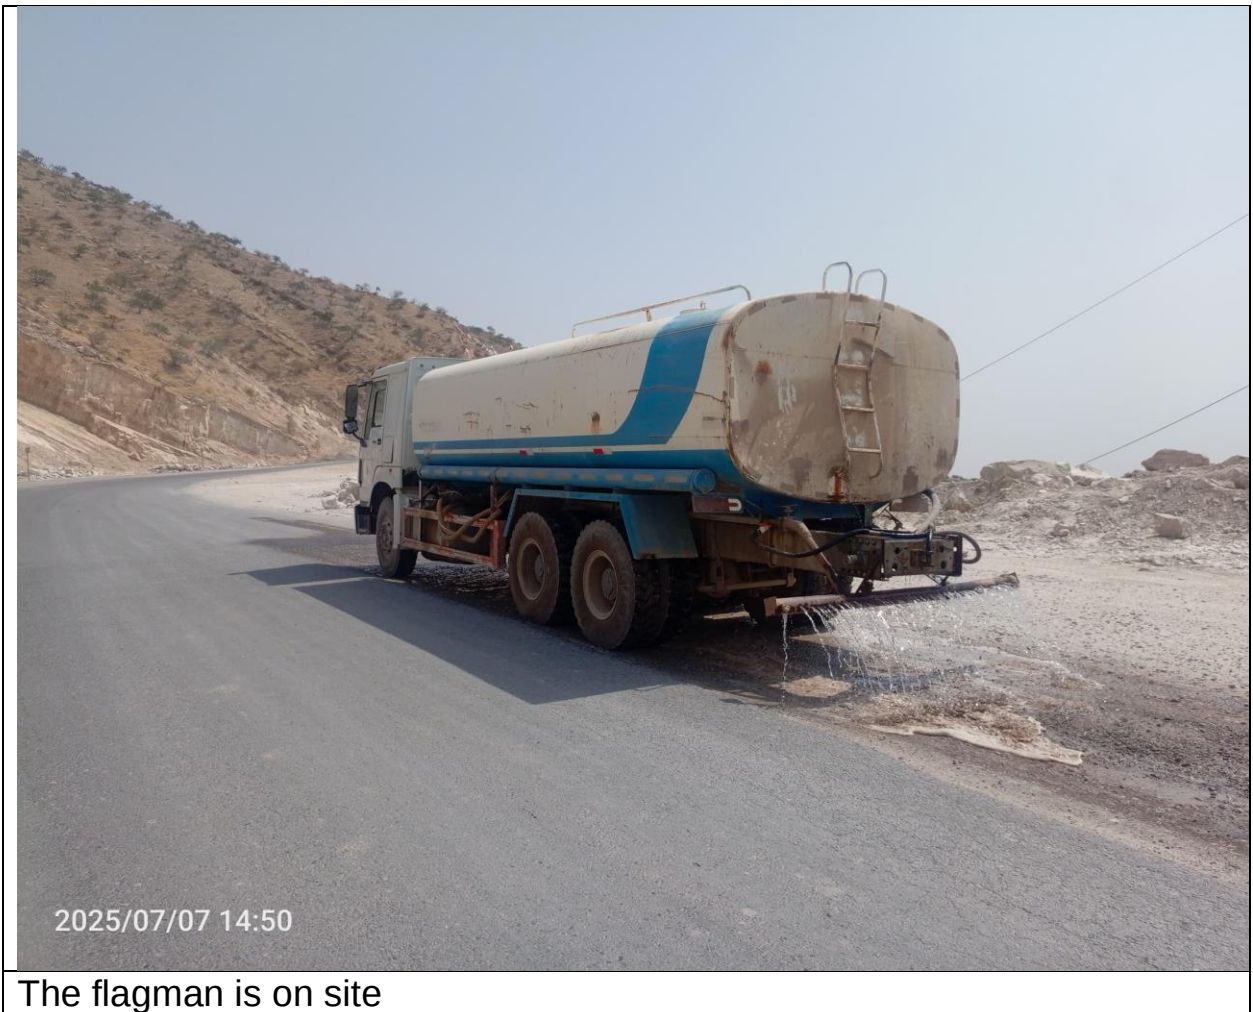
The flagman is on site

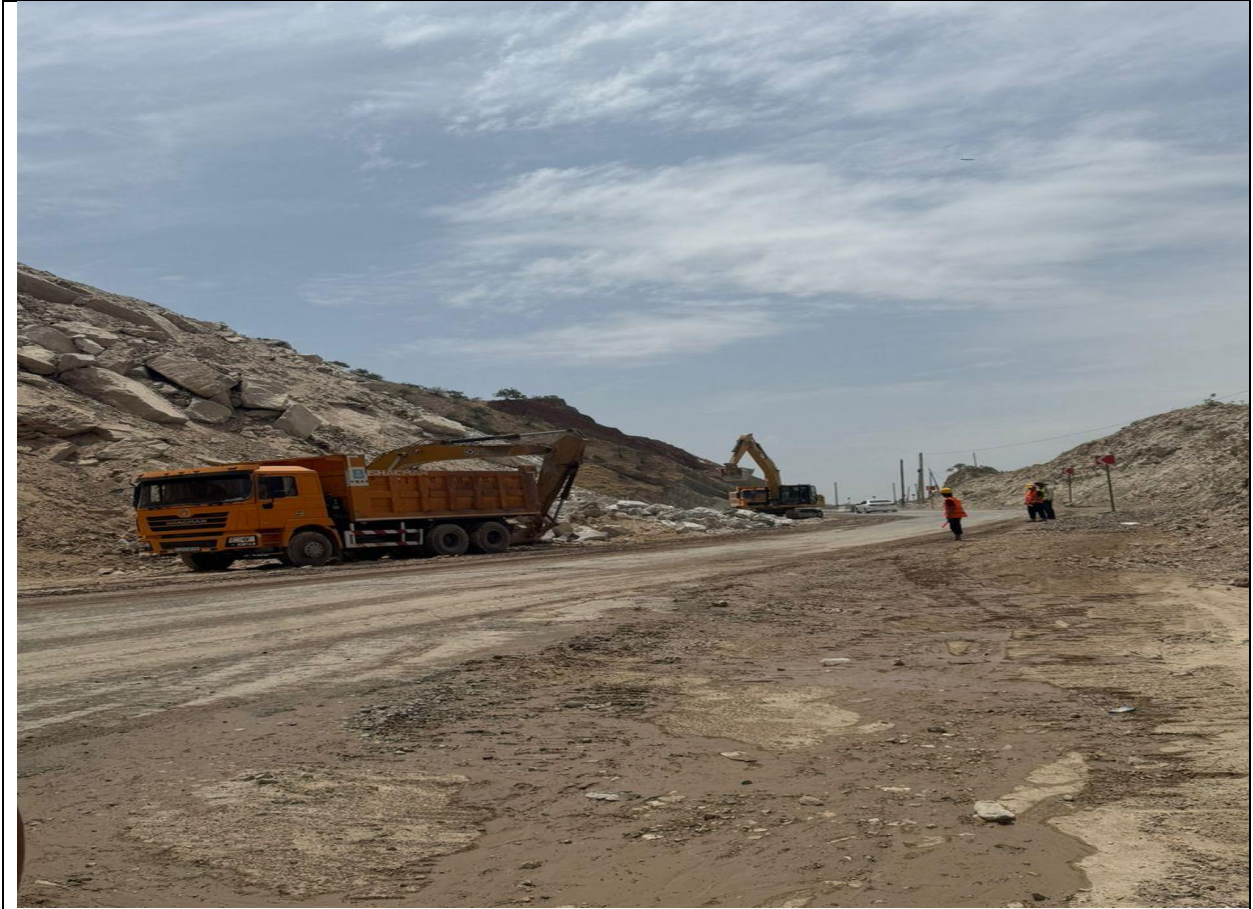
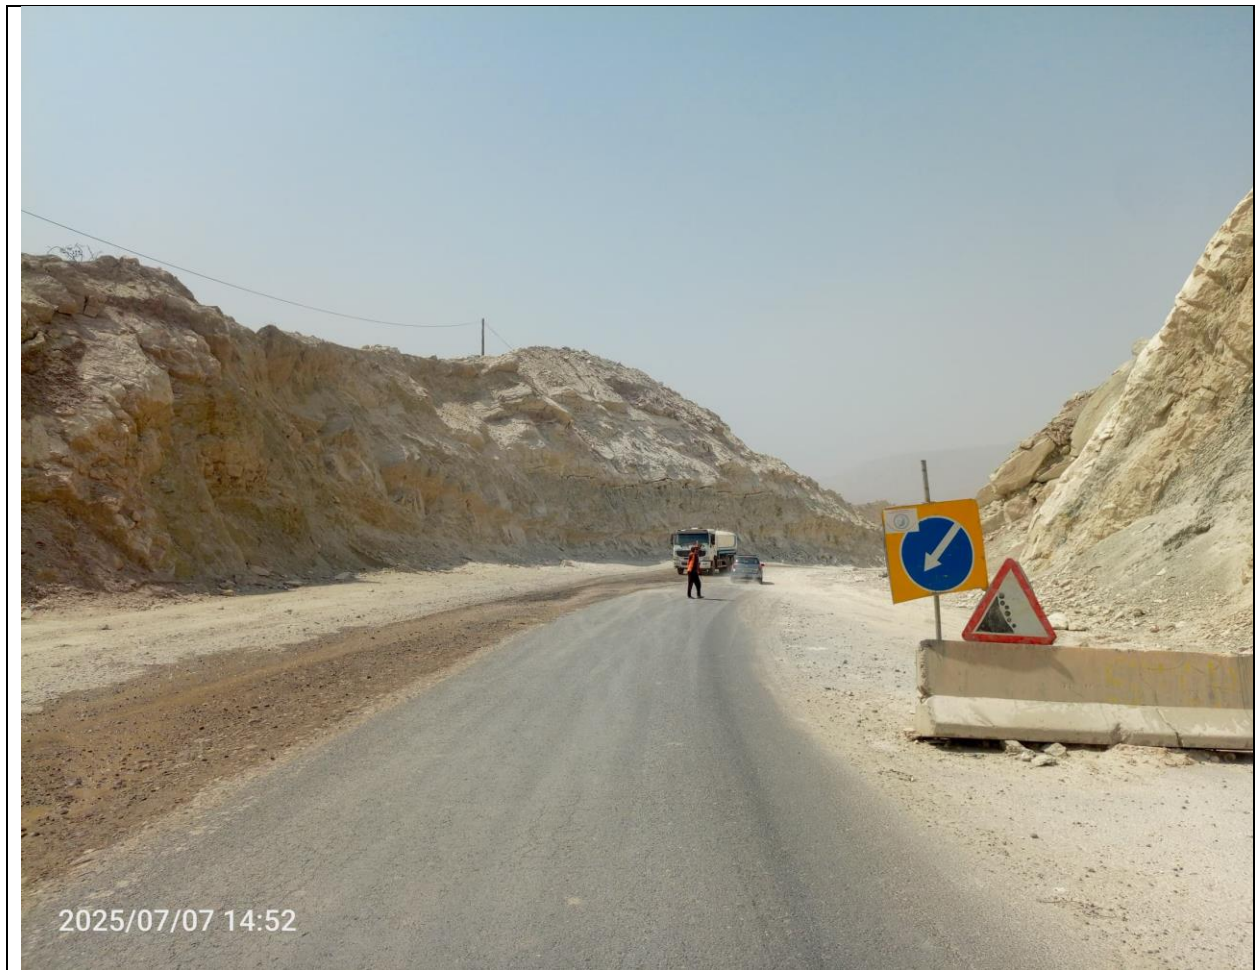
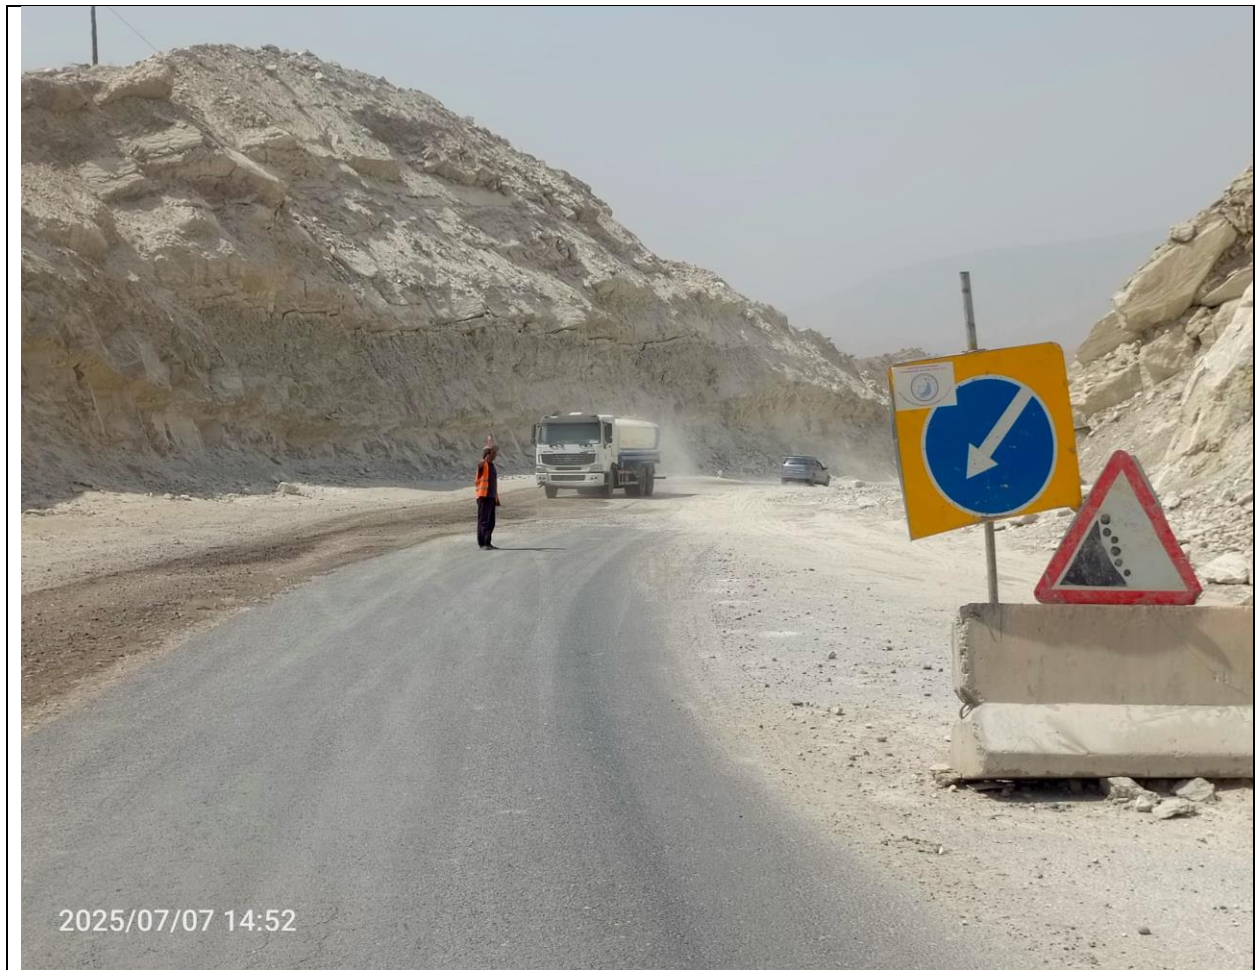
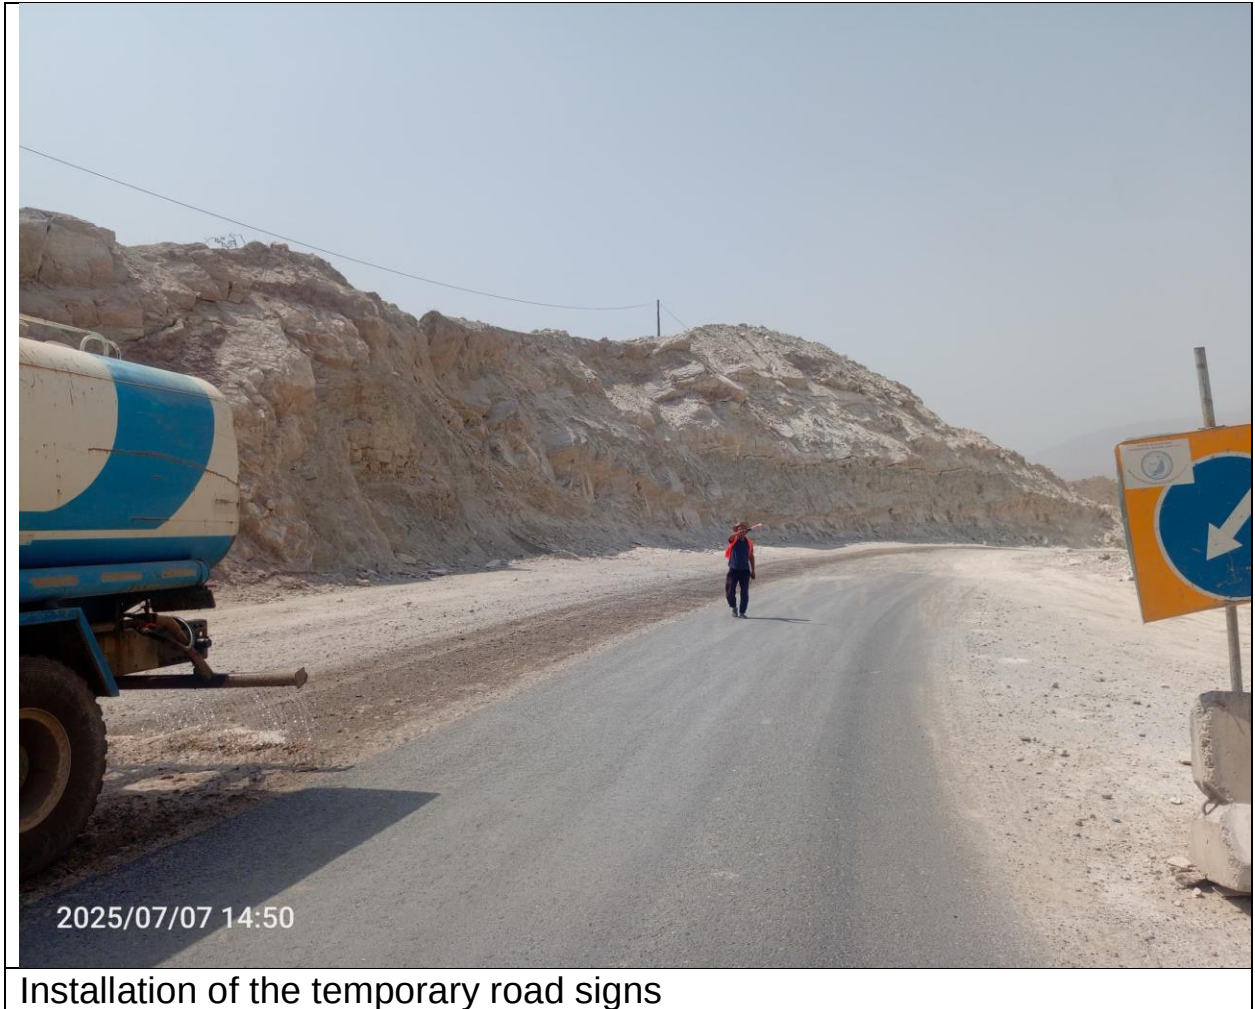
Installation of the temporary road signs
