Project Number: Grant 0859-TAJ  
July 2025

Road Network Sustainability Project (Additional Financing).  
Semi-Annual Environmental Monitoring Report for  
January to June 2025.

Prepared by the Project Implementation Unit of Road Rehabilitation for the Ministry of Transport  
and the Asian Development Bank.

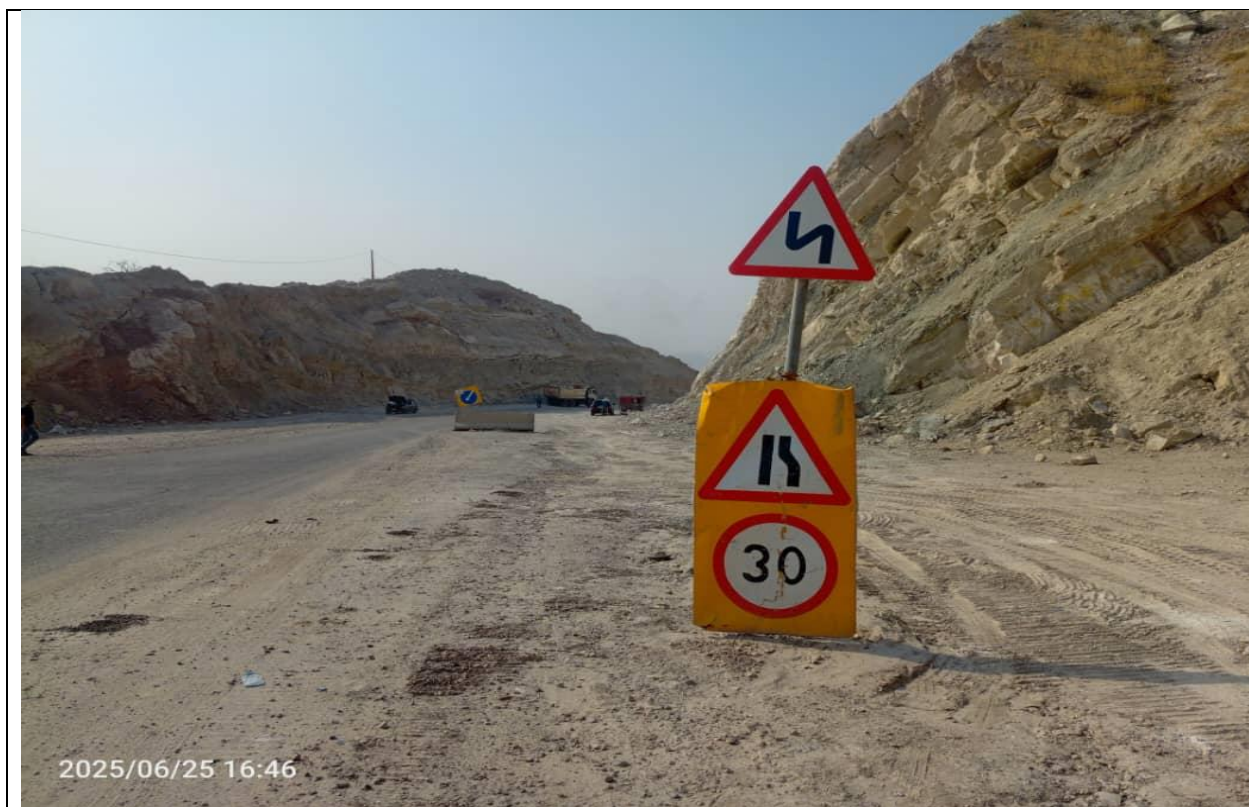
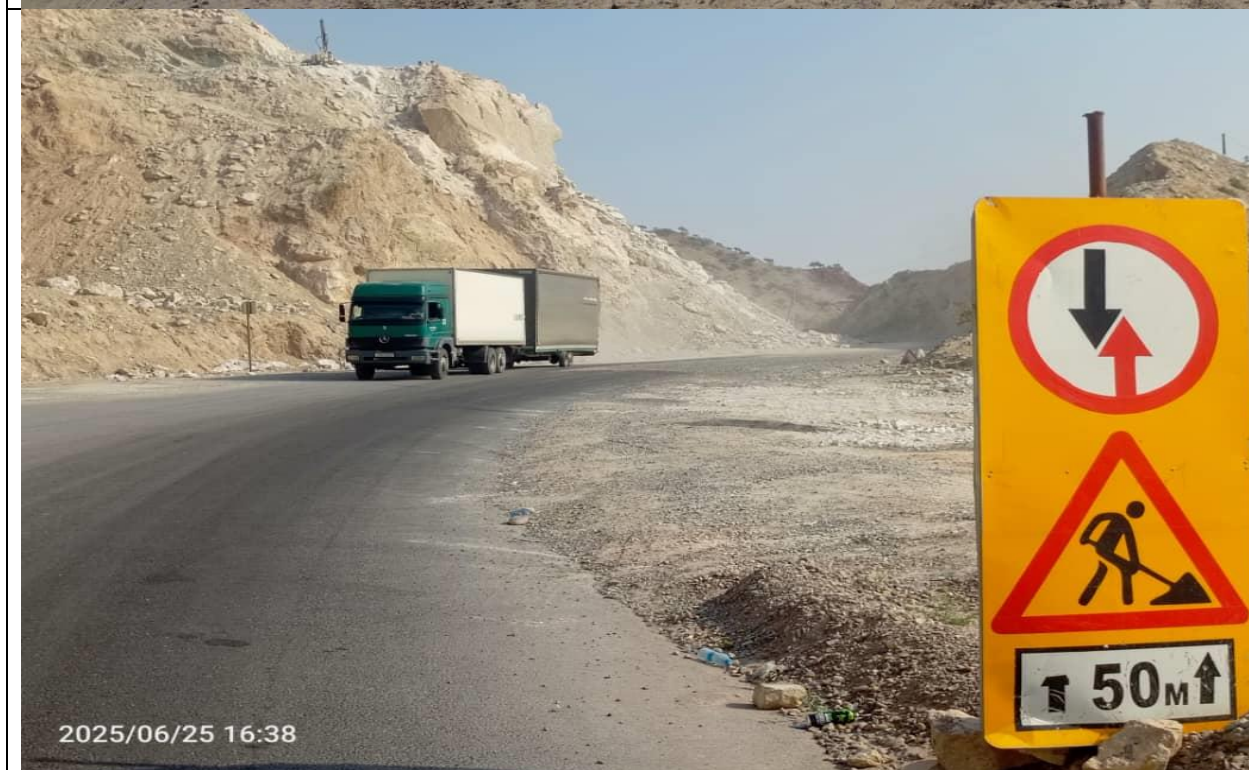
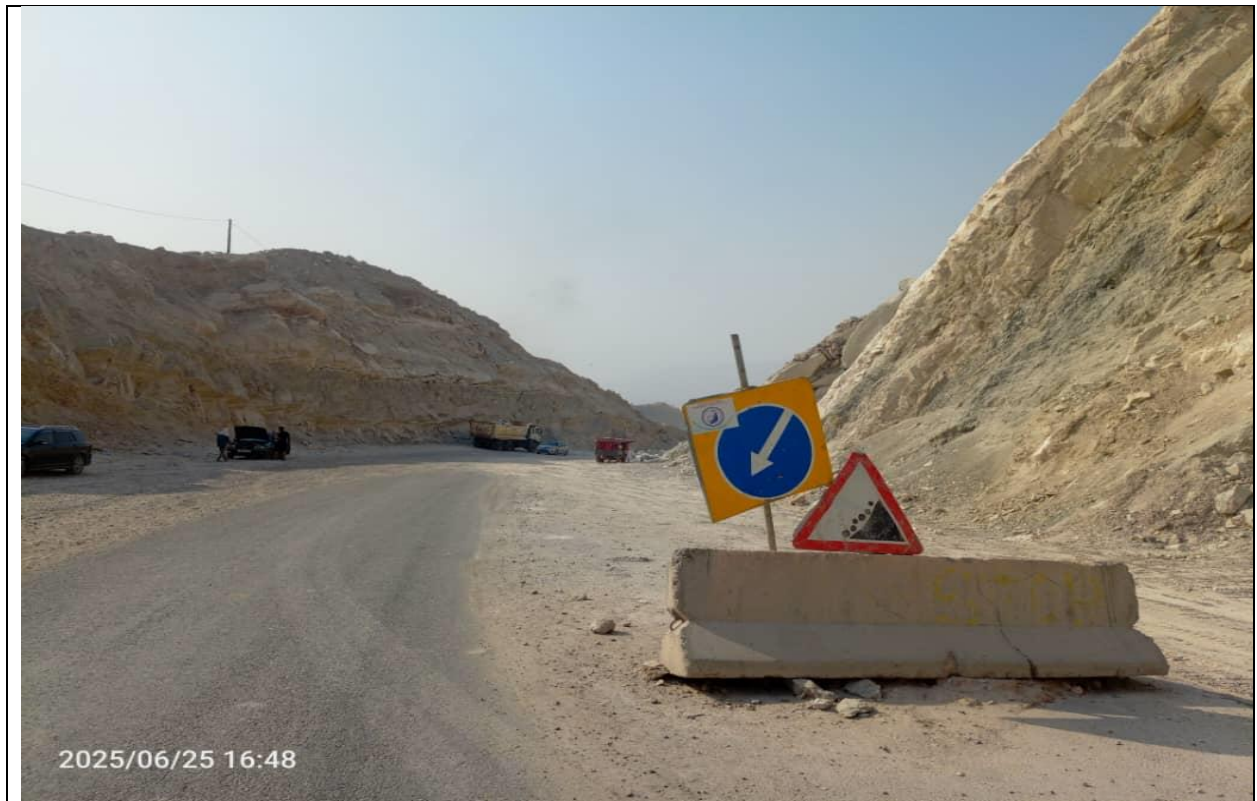
Performing works to eliminate collapse
